Dakota Territory Air Museum's P-47 Update

by Chuck Cravens and John Castorina

AIRCORPS AVIATION

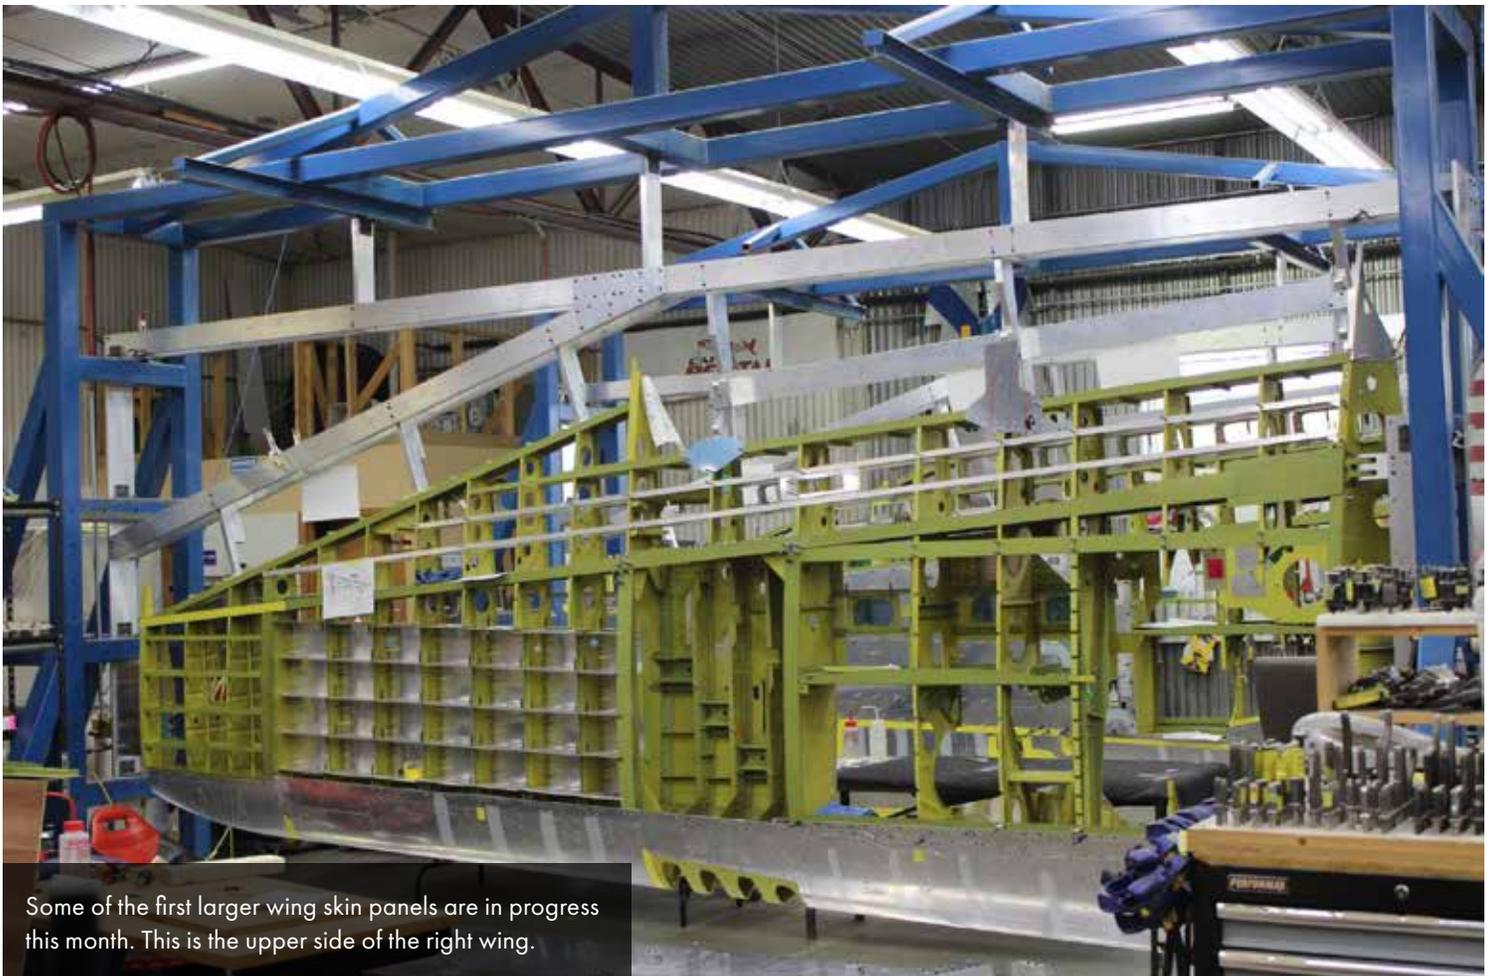
Some of the first larger wing skin panels are in progress this month. This is the upper side of the right wing.

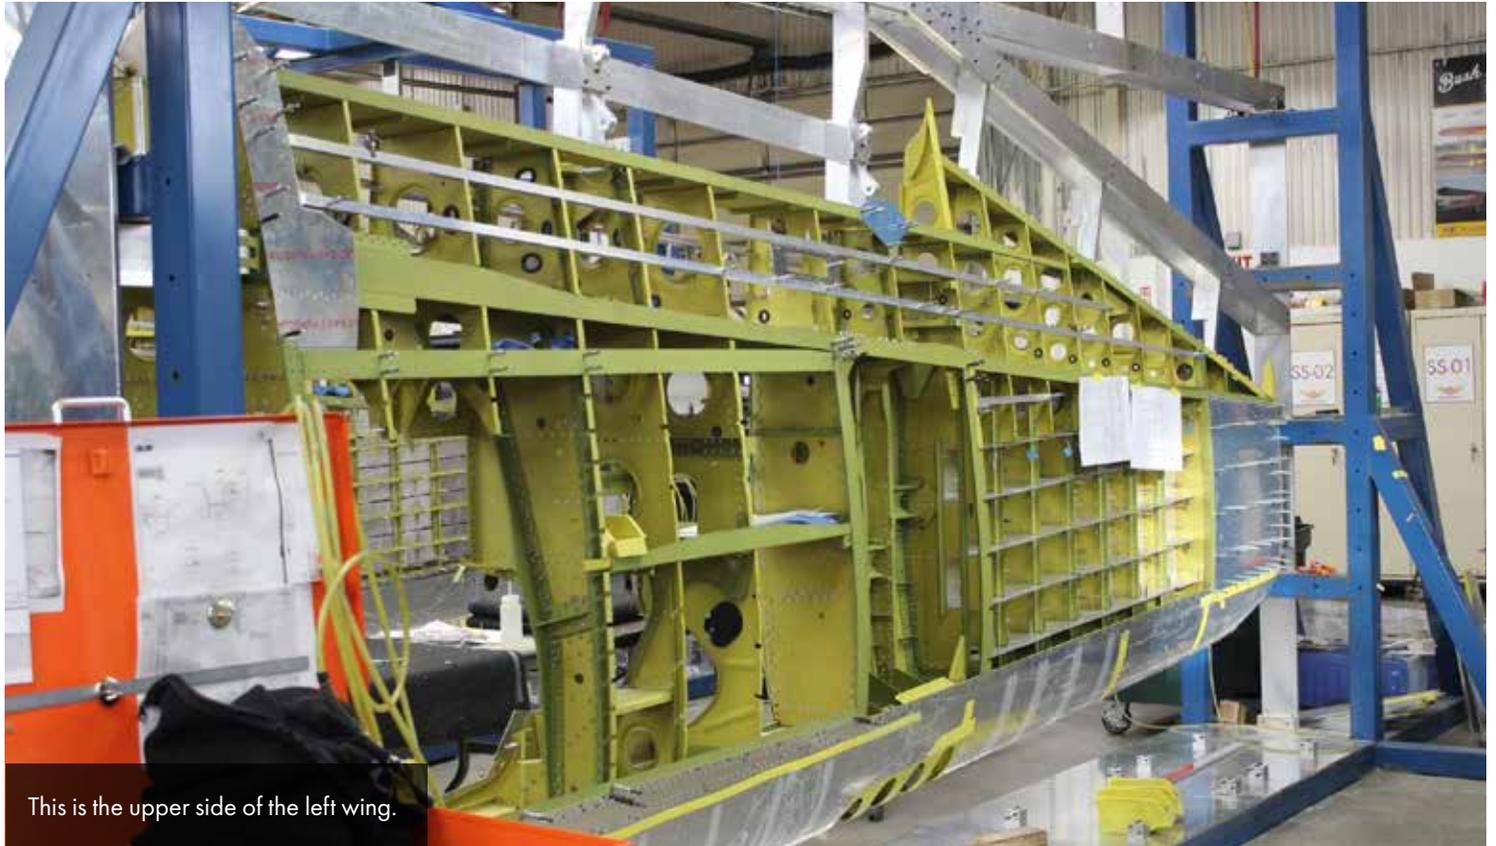
This is the upper side of the left wing.

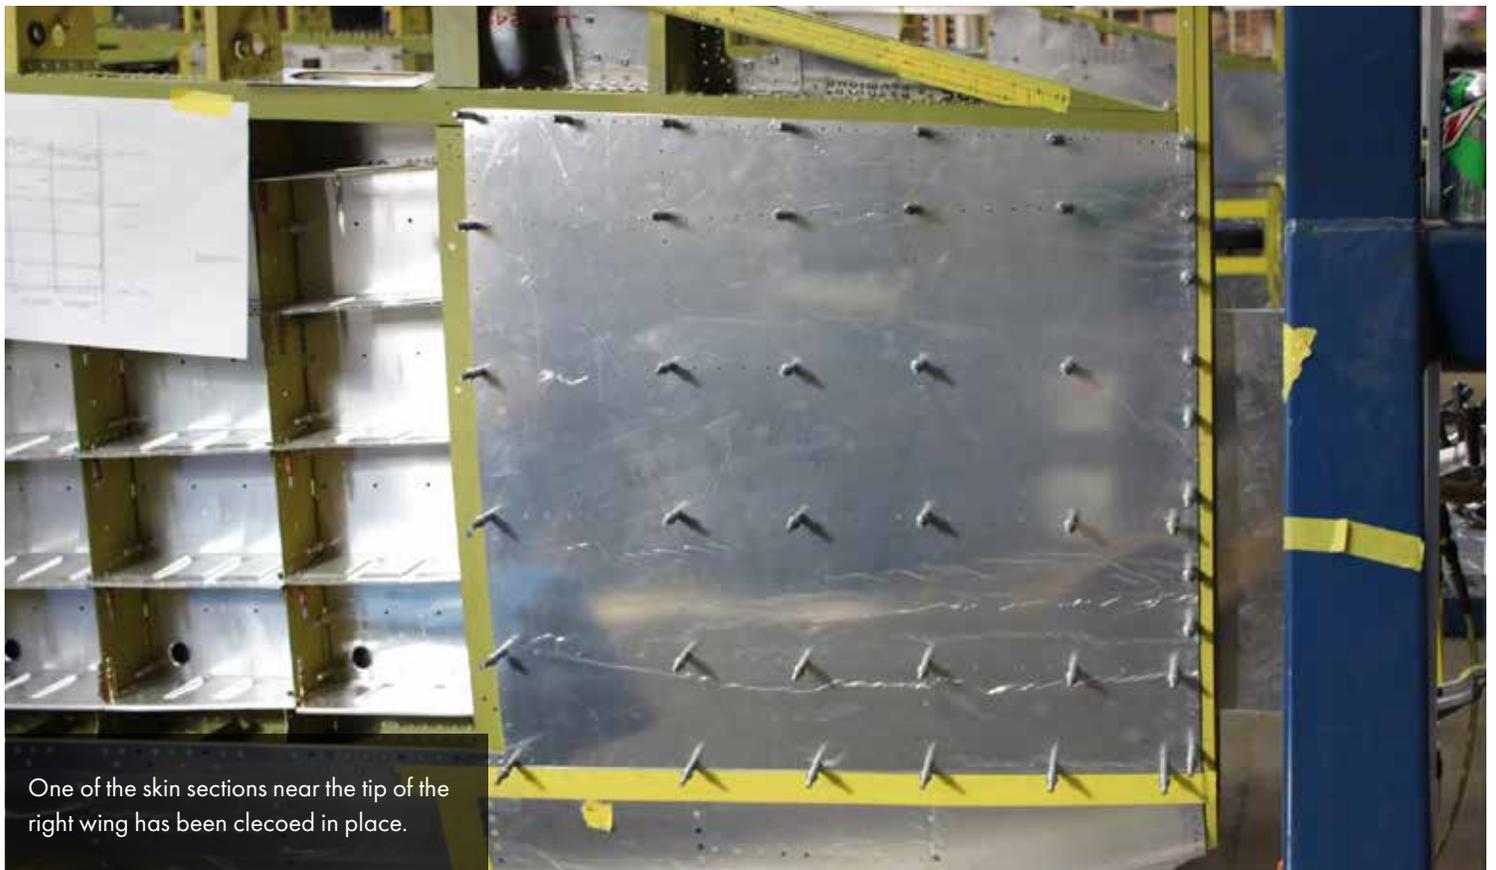
One of the skin sections near the tip of the right wing has been clecoed in place.

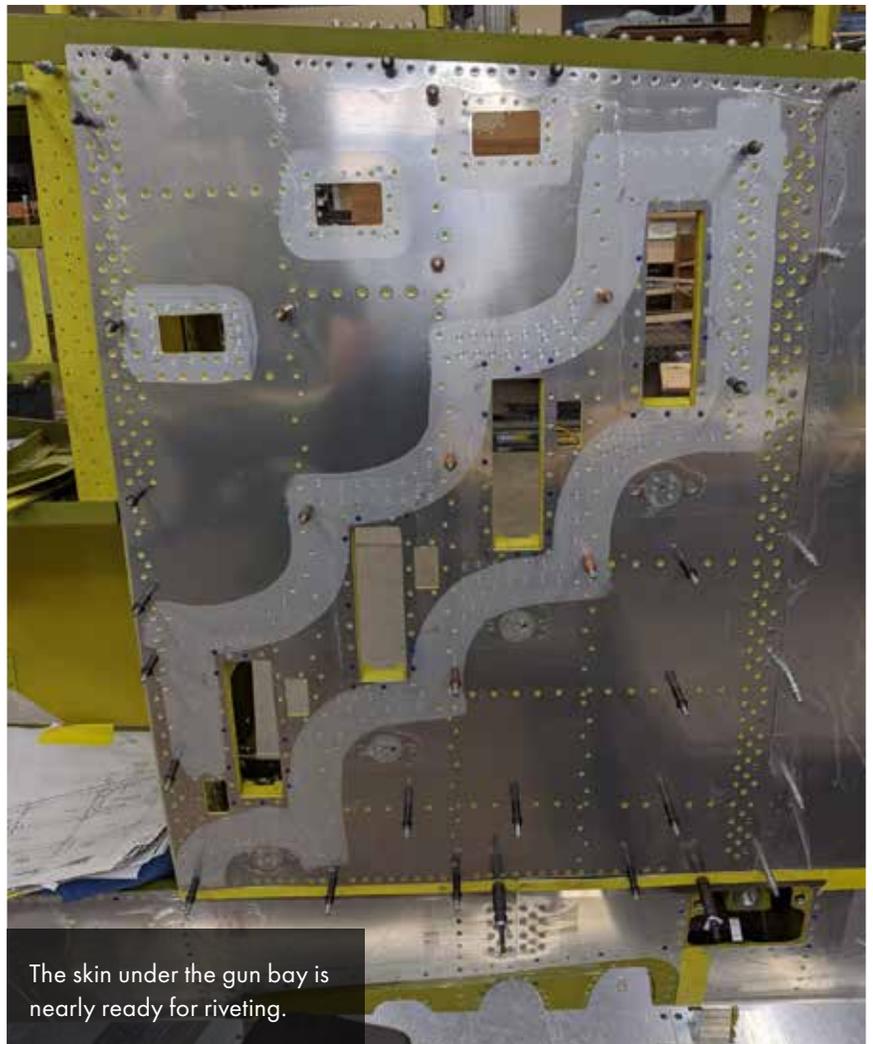
The skin under the gun bay is nearly ready for riveting.

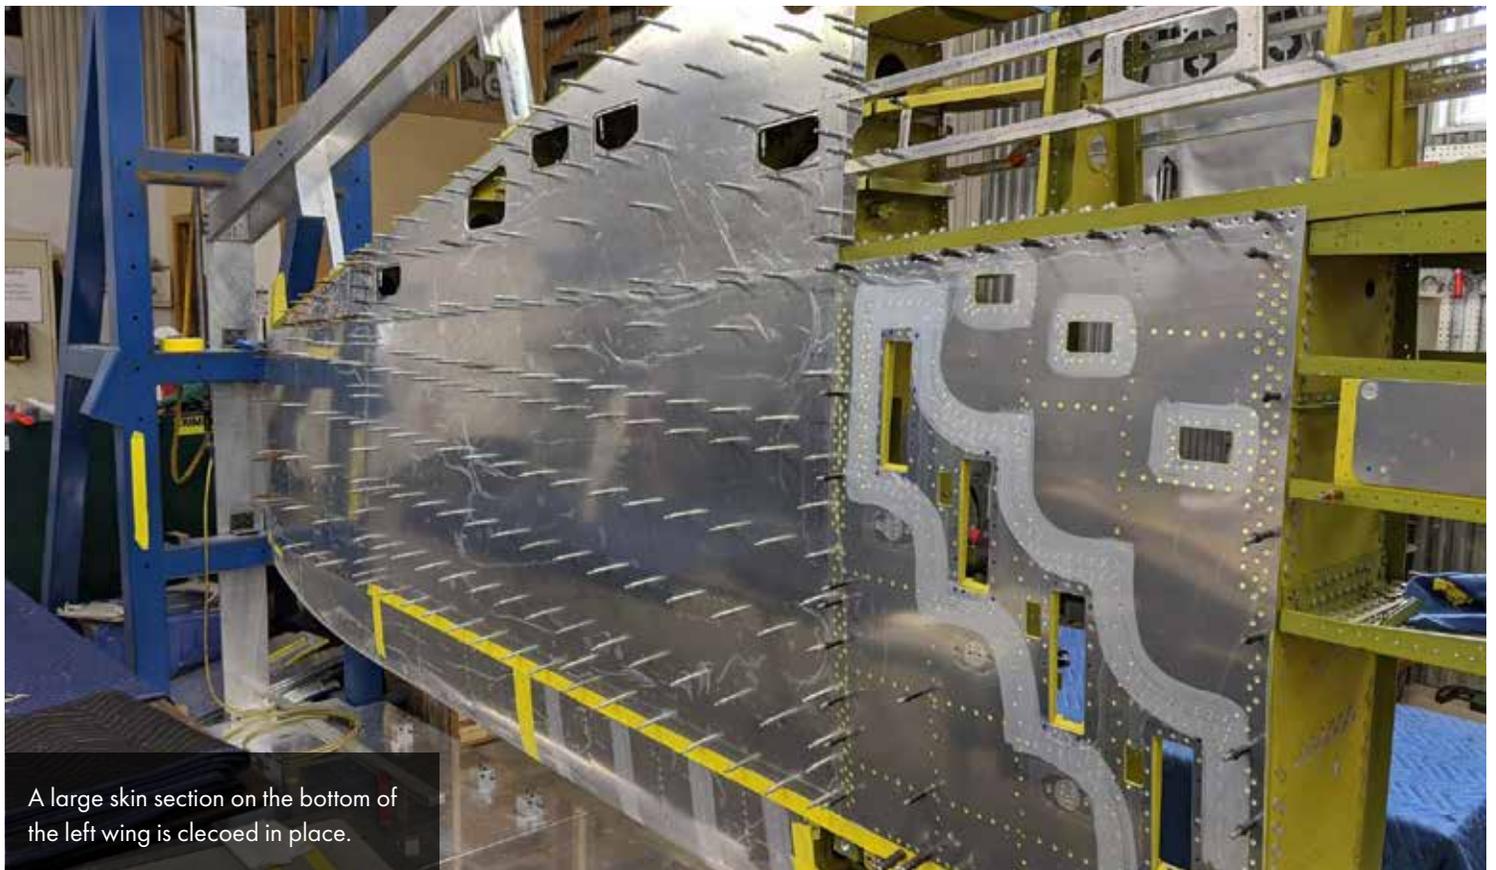
A large skin section on the bottom of the left wing is cleced in place.

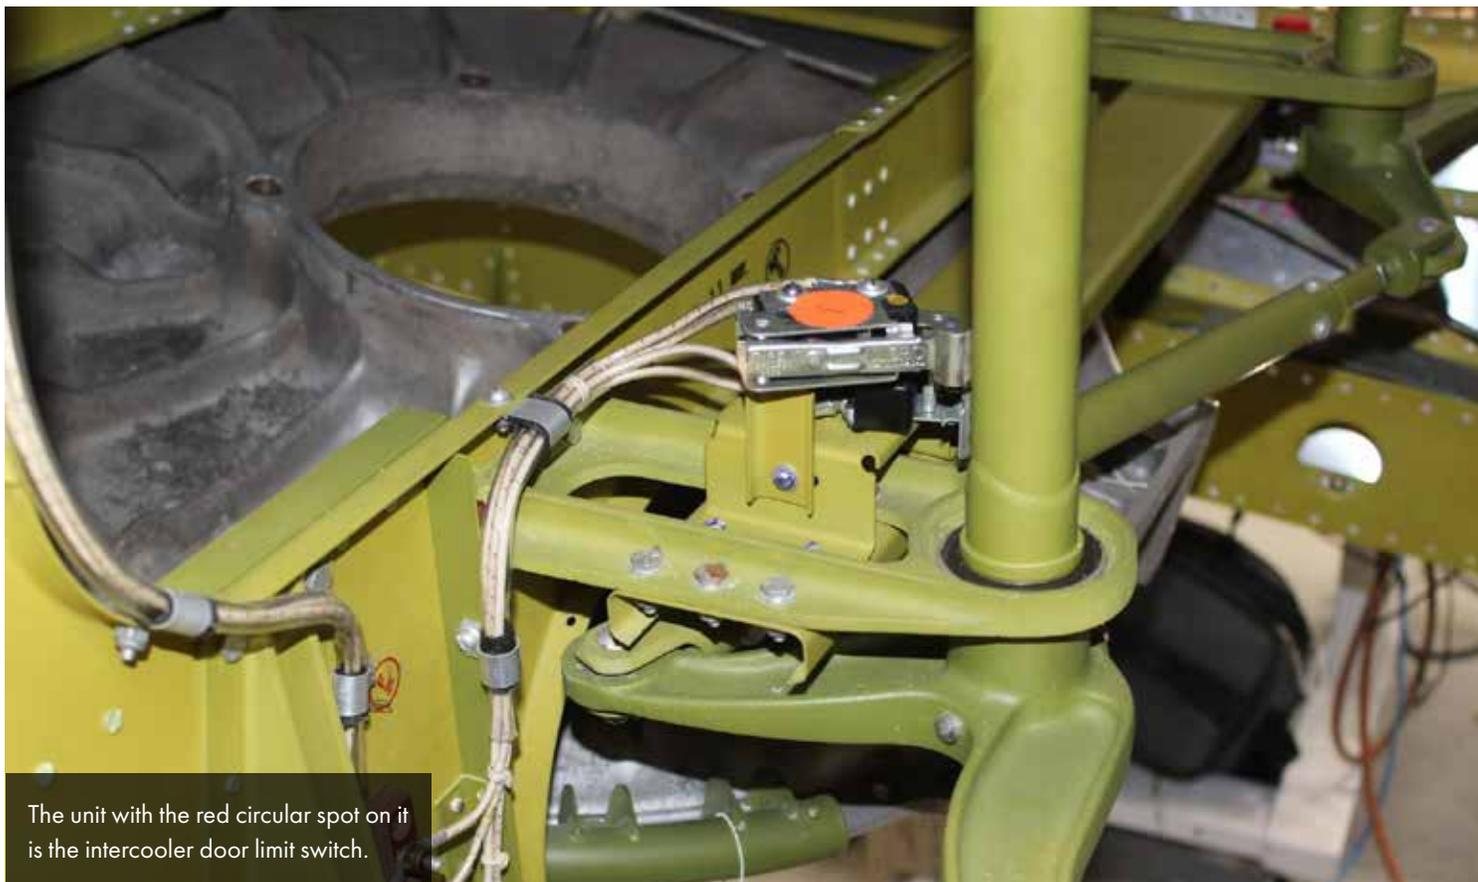
The unit with the red circular spot on it is the intercooler door limit switch.

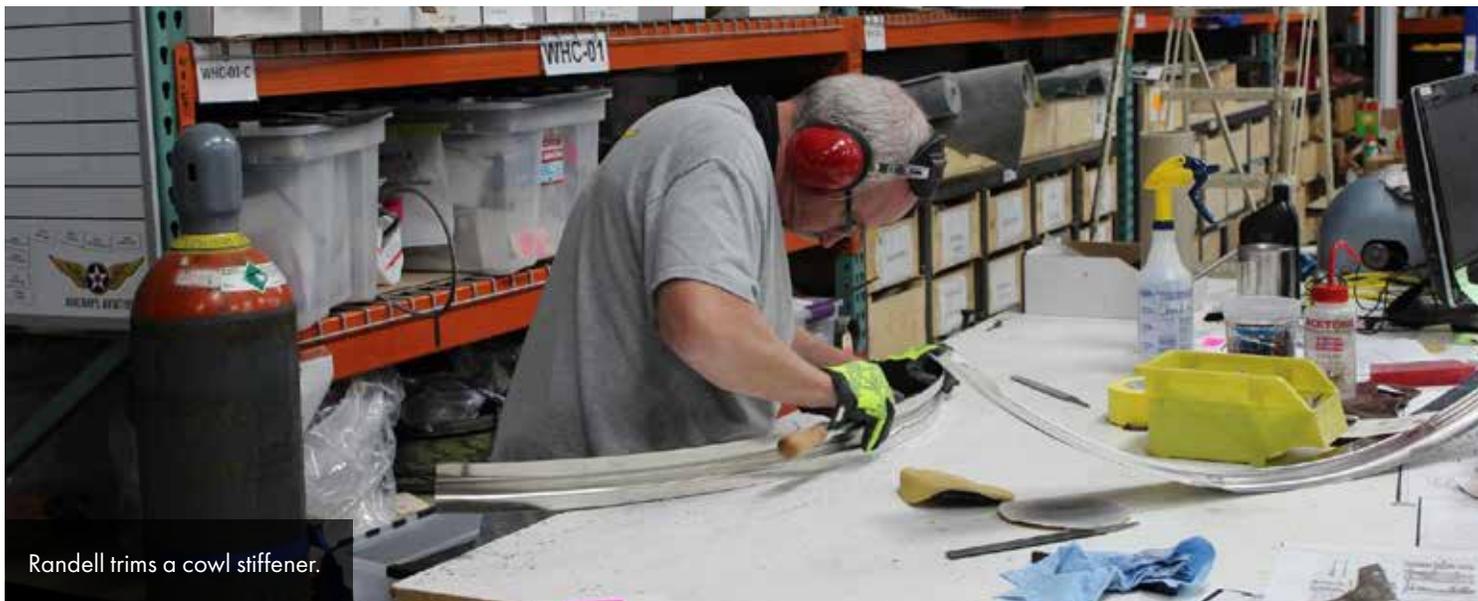
Randell trims a cowl stiffener.

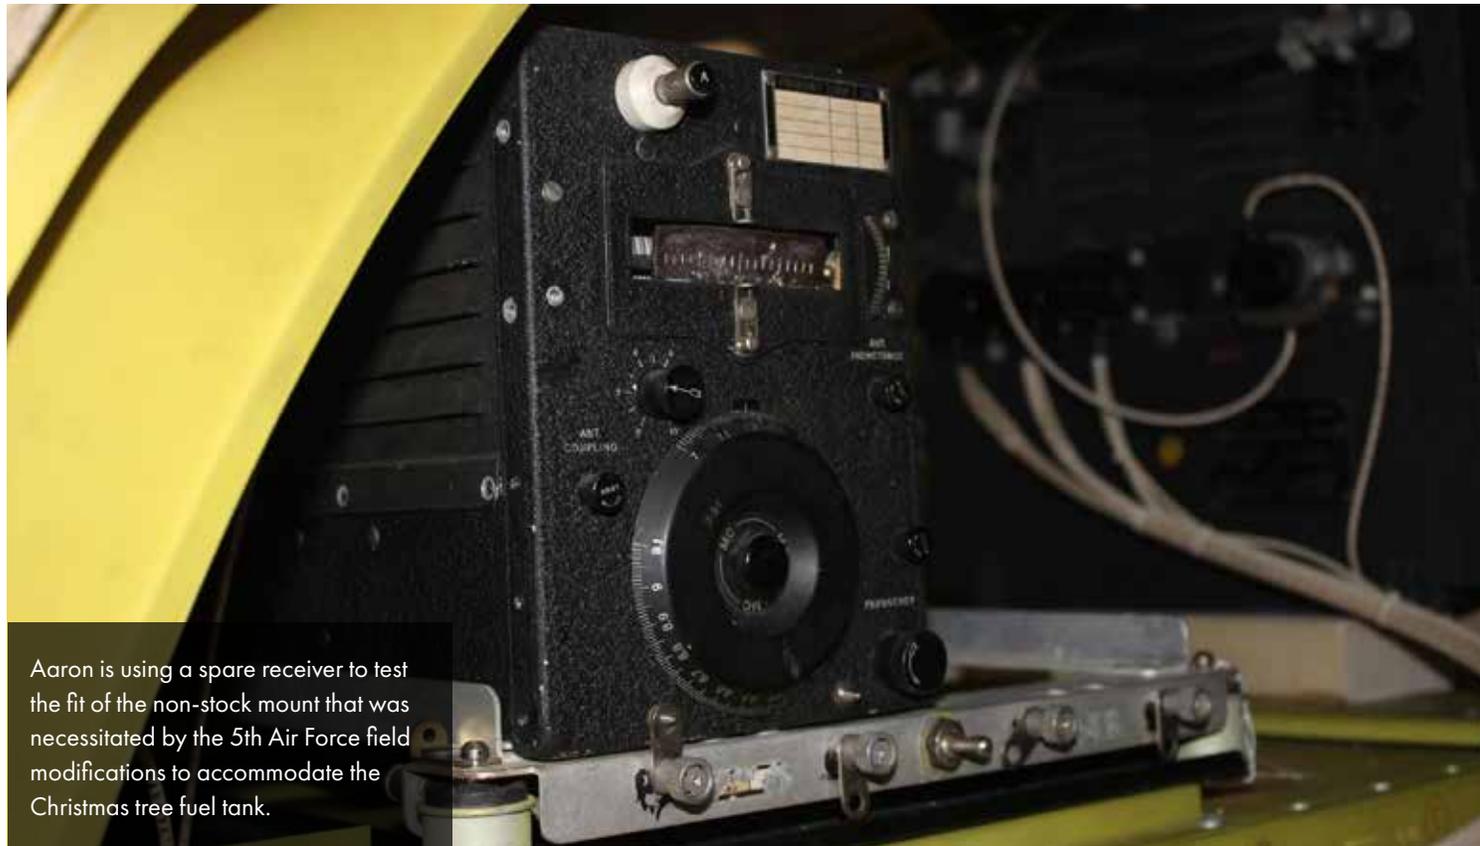
Aaron is using a spare receiver to test the fit of the non-stock mount that was necessitated by the 5th Air Force field modifications to accommodate the Christmas tree fuel tank.

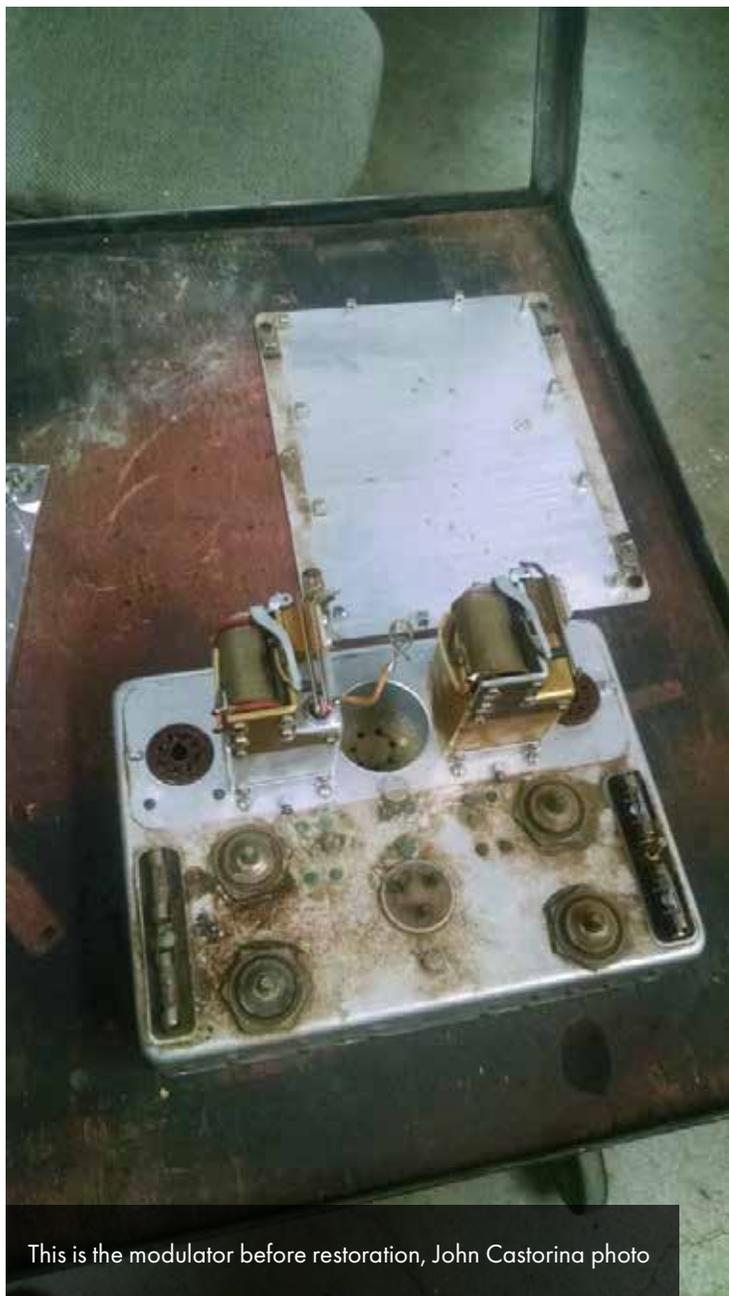
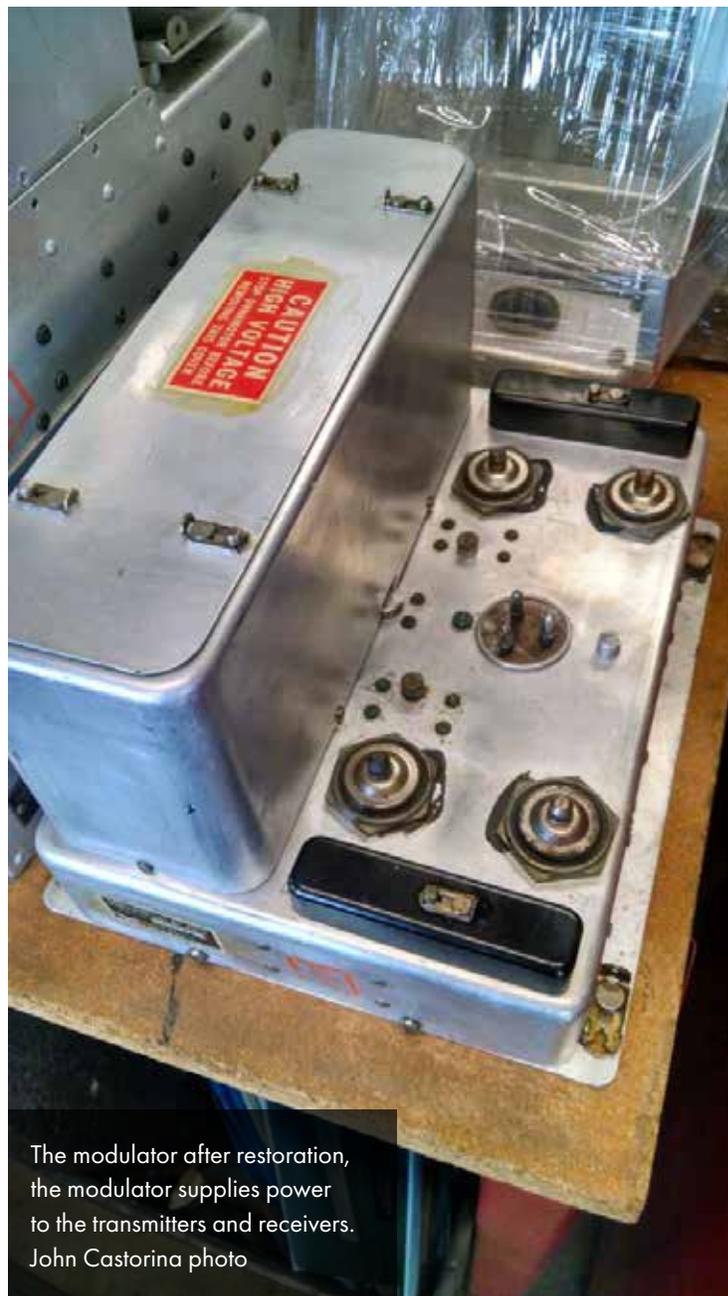
This is the modulator before restoration, John Castorina photo

The modulator after restoration, the modulator supplies power to the transmitters and receivers. John Castorina photo

All installations required one modulator, which also supplies power to the transmitters, and appropriate control boxes and mountings. Operating in the High Frequency (HF) range, four different receivers and four different transmitters cover the frequency range 0.19 mhz to 9.1 mhz. The transmitter power output ranges from about 40 to 60 watts, depending on mode (AM voice, cw, or amplitude modulated cw).

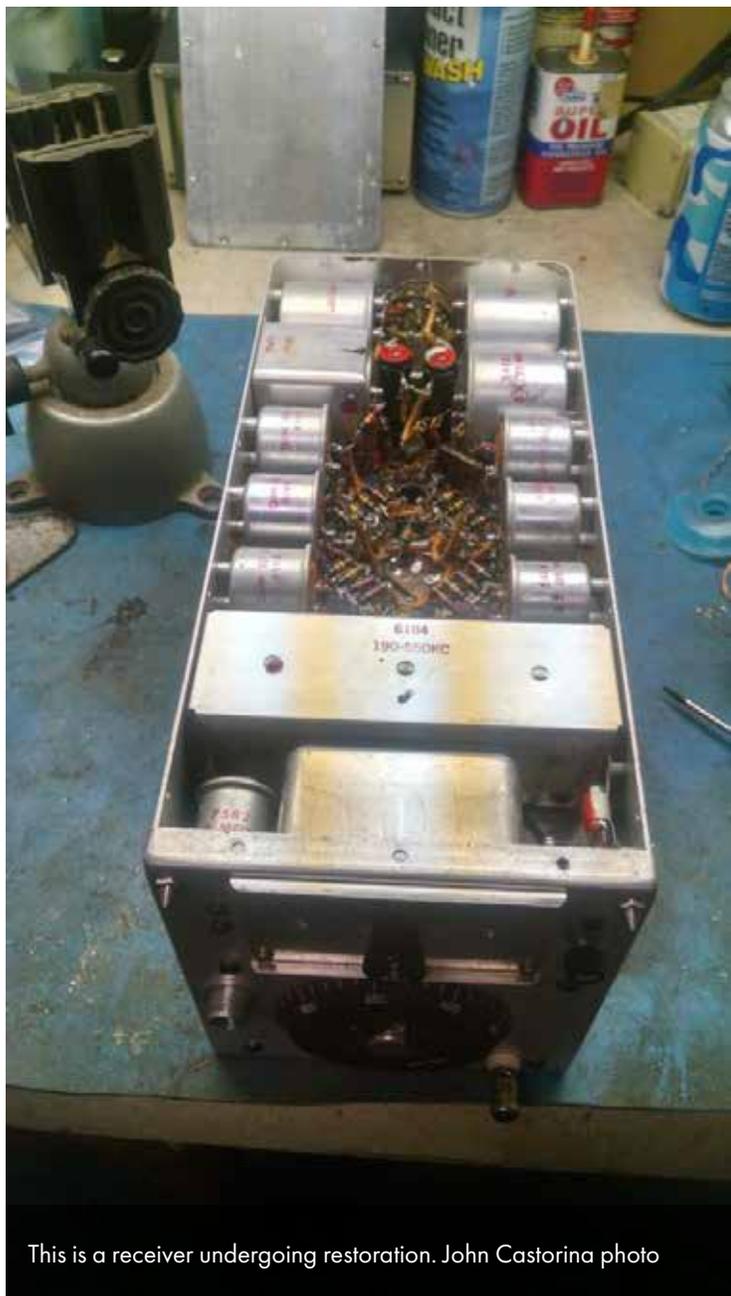
This is a receiver undergoing restoration. John Castorina photo

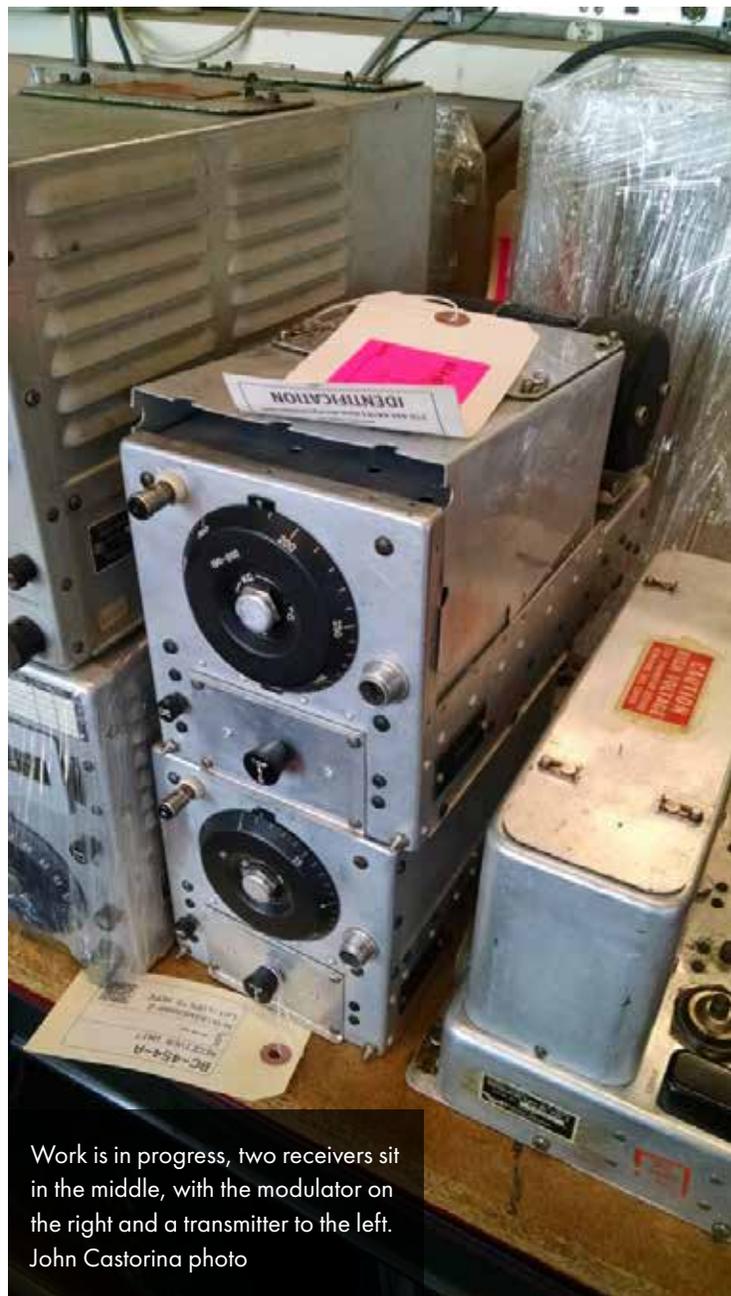
Work is in progress, two receivers sit in the middle, with the modulator on the right and a transmitter to the left. John Castorina photo

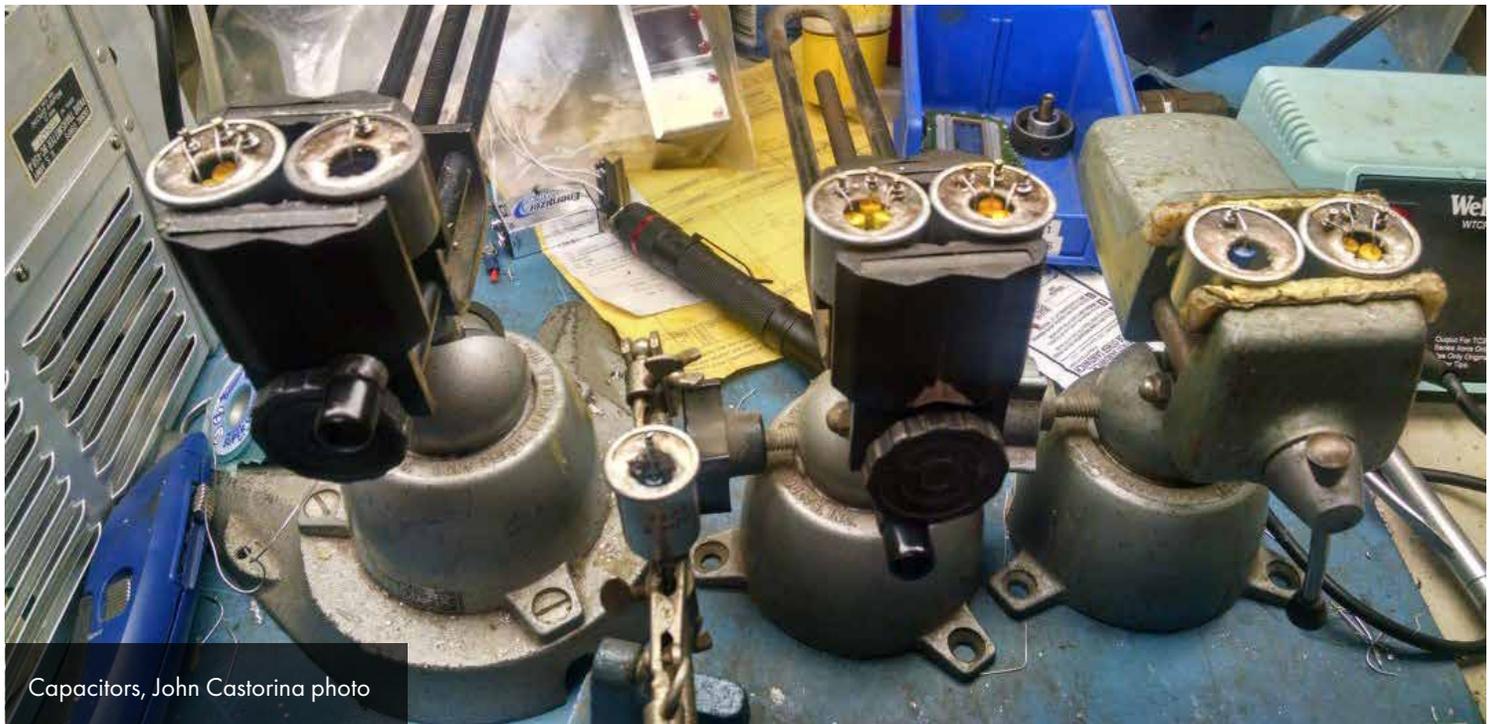
Capacitors, John Castorina photo

The second most time-consuming task (after cosmetic restoration) is the removal and replacement of every capacitor in each transmitter and receiver. Capacitors are the first items to die electrically, and most have long ago reached this stage. To maintain the original appearance, the capacitor cases are gutted, then new modern components are installed in the original case, followed by cosmetic work to ensure the final appearance is close to what it was when the units were built. Dynamotors are opened, cleaned, and old (usually hardened) grease is removed from the bearings. New grease is packed in, and brushes are checked and replaced if necessary.

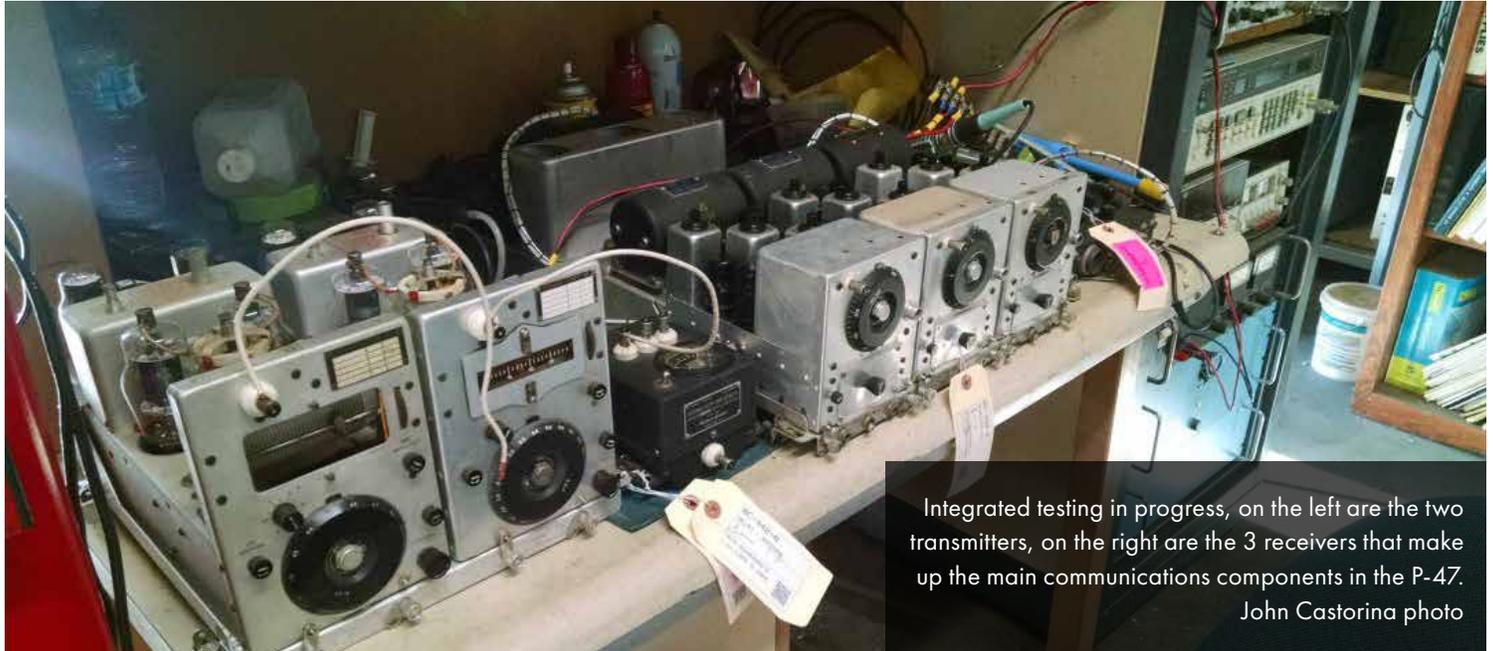
Integrated testing in progress, on the left are the two transmitters, on the right are the 3 receivers that make up the main communications components in the P-47.  
John Castorina photo

The initial test consists simply of applying power to each unit, listening for defects in the dynamotors and observing that none of the magic black smoke gets out of any part of the radio set. Now a functional test - headsets and signal generators are connected to the receivers, power meters are connected to the transmitters, then a check is made of each unit that basic functions are working. Units which fail this check are isolated and repaired as required before continuing with the test procedures. It is worth mentioning that out of at least 20 transmitters and receivers I've restored, I can think of only a couple of units that did not work the first time at this point – pretty good considering the age!

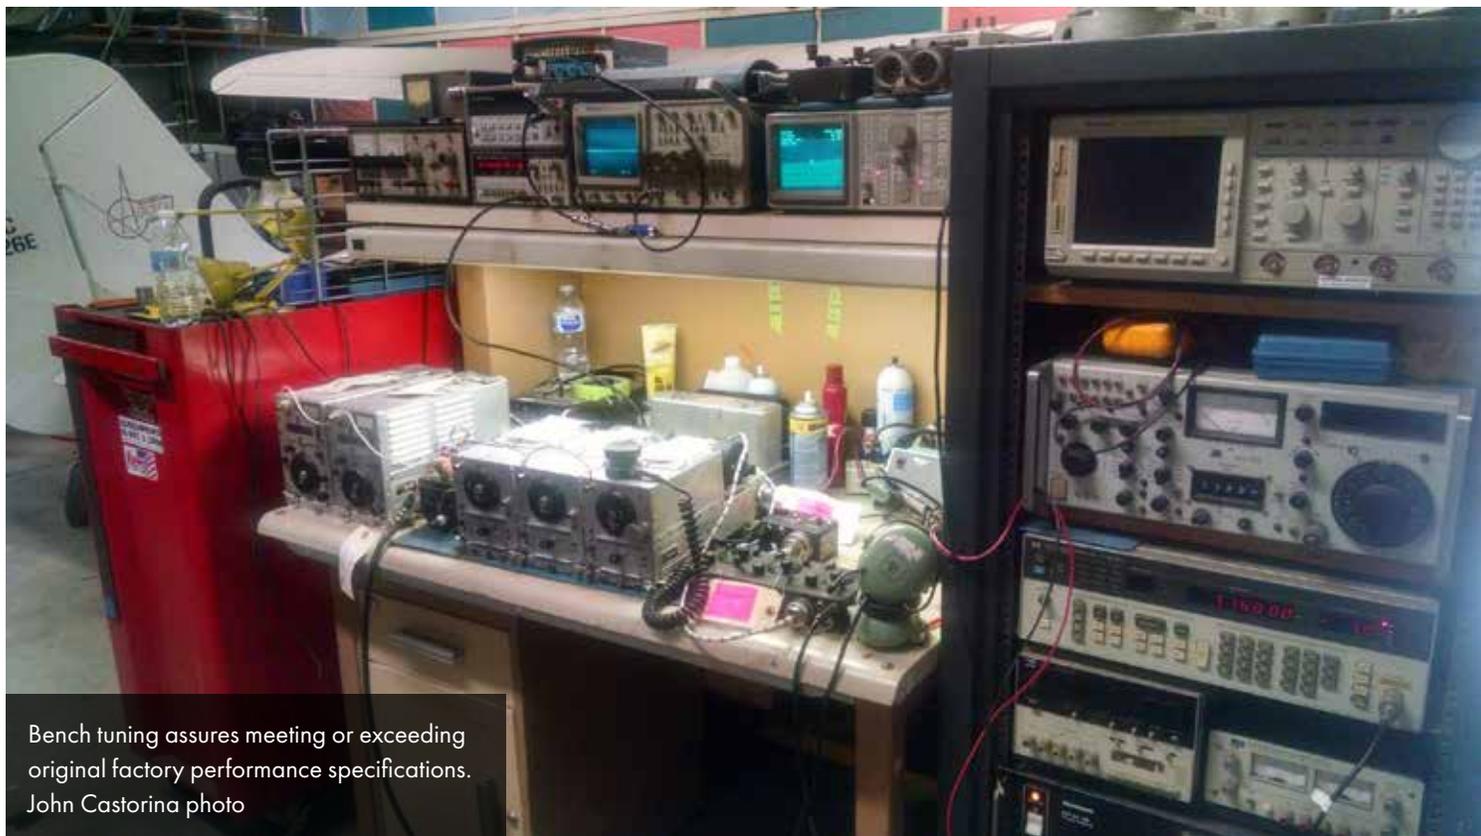
Bench tuning assures meeting or exceeding original factory performance specifications.  
John Castorina photo

Using modern digital test equipment, each unit is then tuned for performance to be equal to or better than the factory specifications. This involves precise measurement of receiver sensitivity, dial calibration, transmitter power output across the tuning range at multiple frequencies, audio output and distortion.

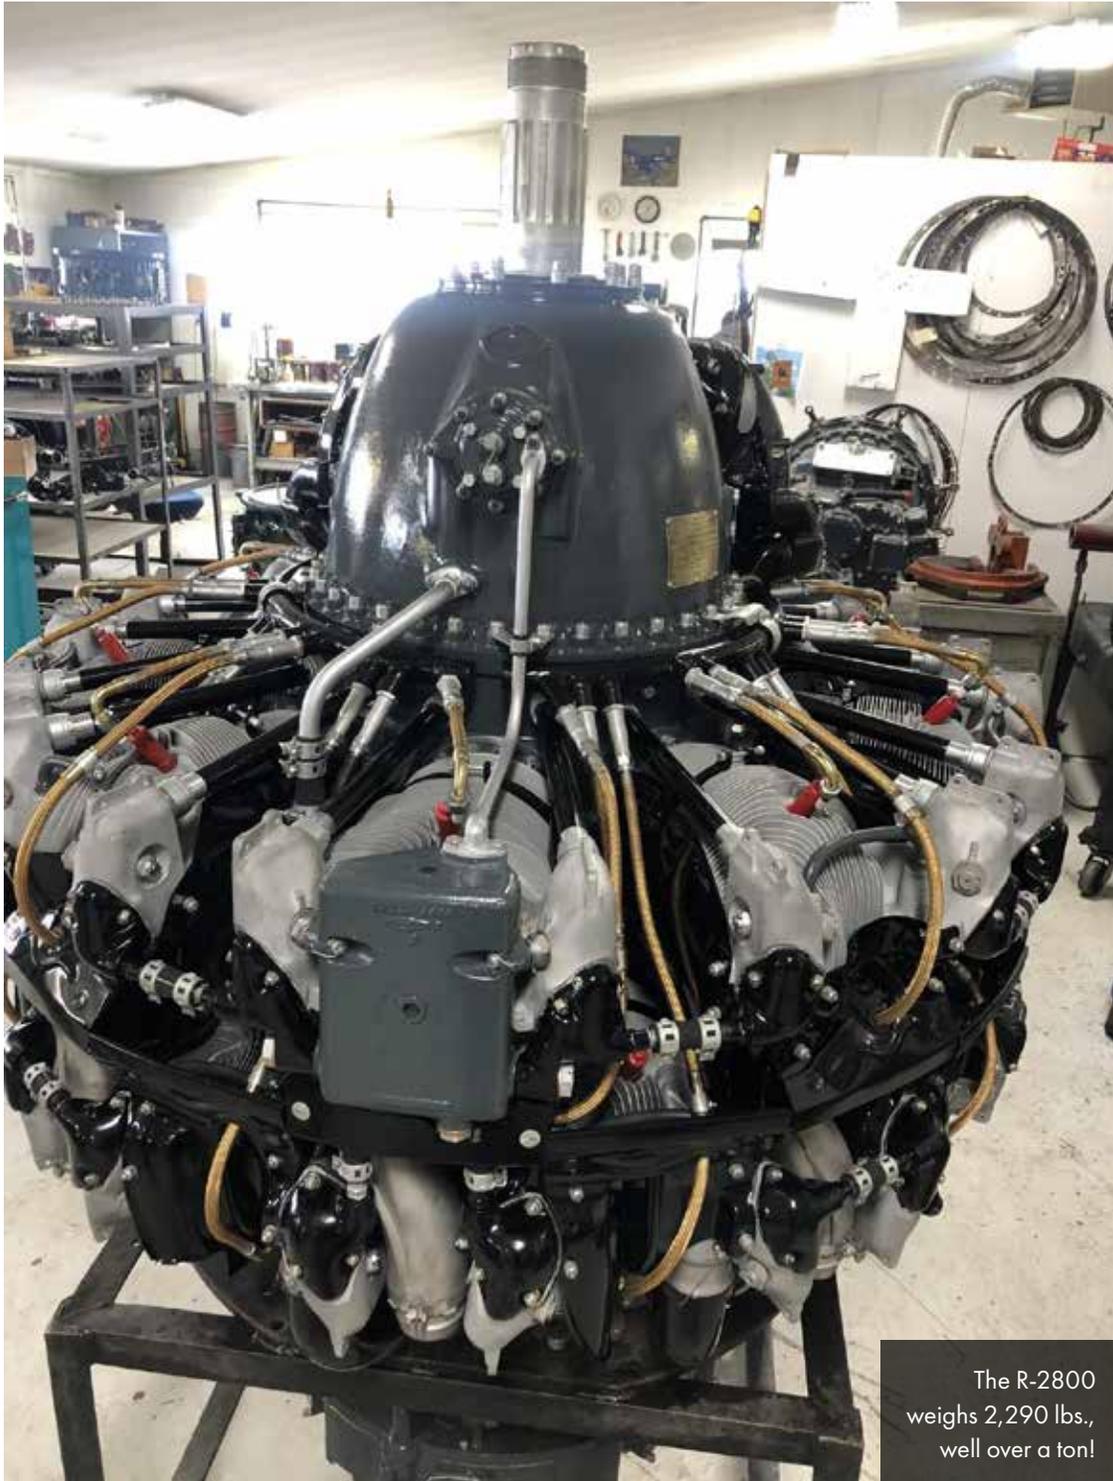
The R-2800 weighs 2,290 lbs., well over a ton!

The R-2800 is an eighteen cylinder, double row, air cooled radial engine. The cylinder bore is 5.75 inches and the stroke is 6.0 inches, resulting in a total displacement of 2804 cubic inches.

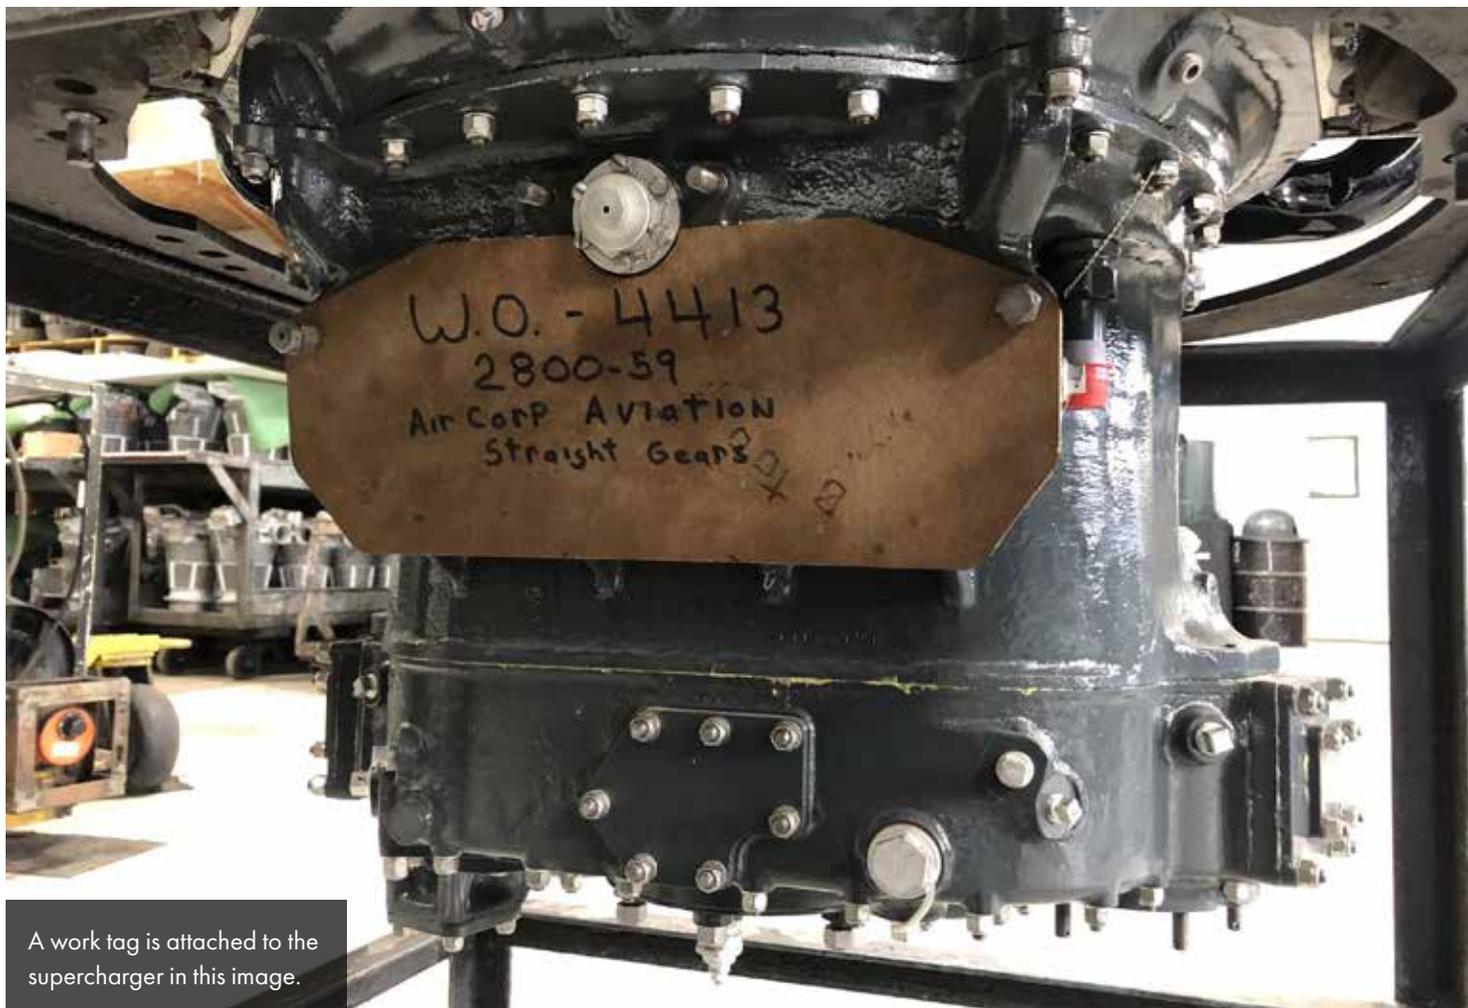
A work tag is attached to the supercharger in this image.

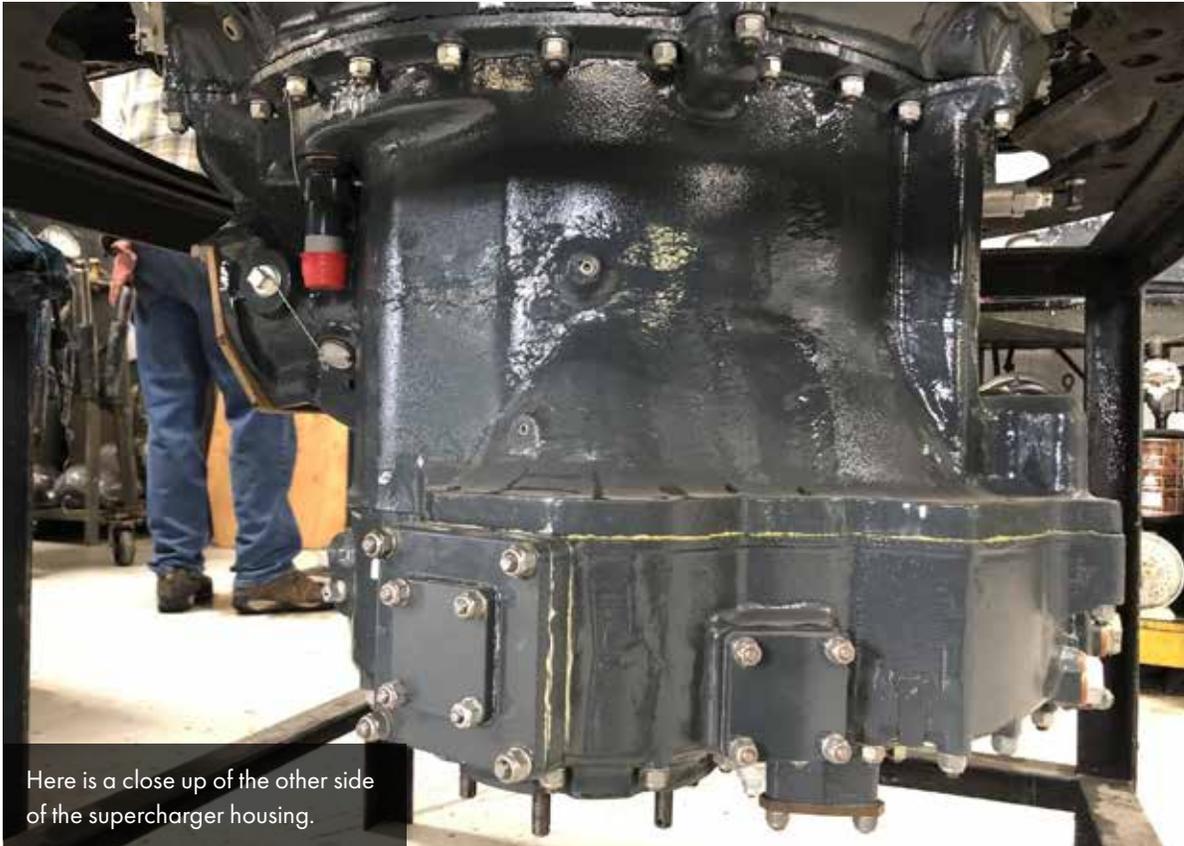
Here is a close up of the other side of the supercharger housing.

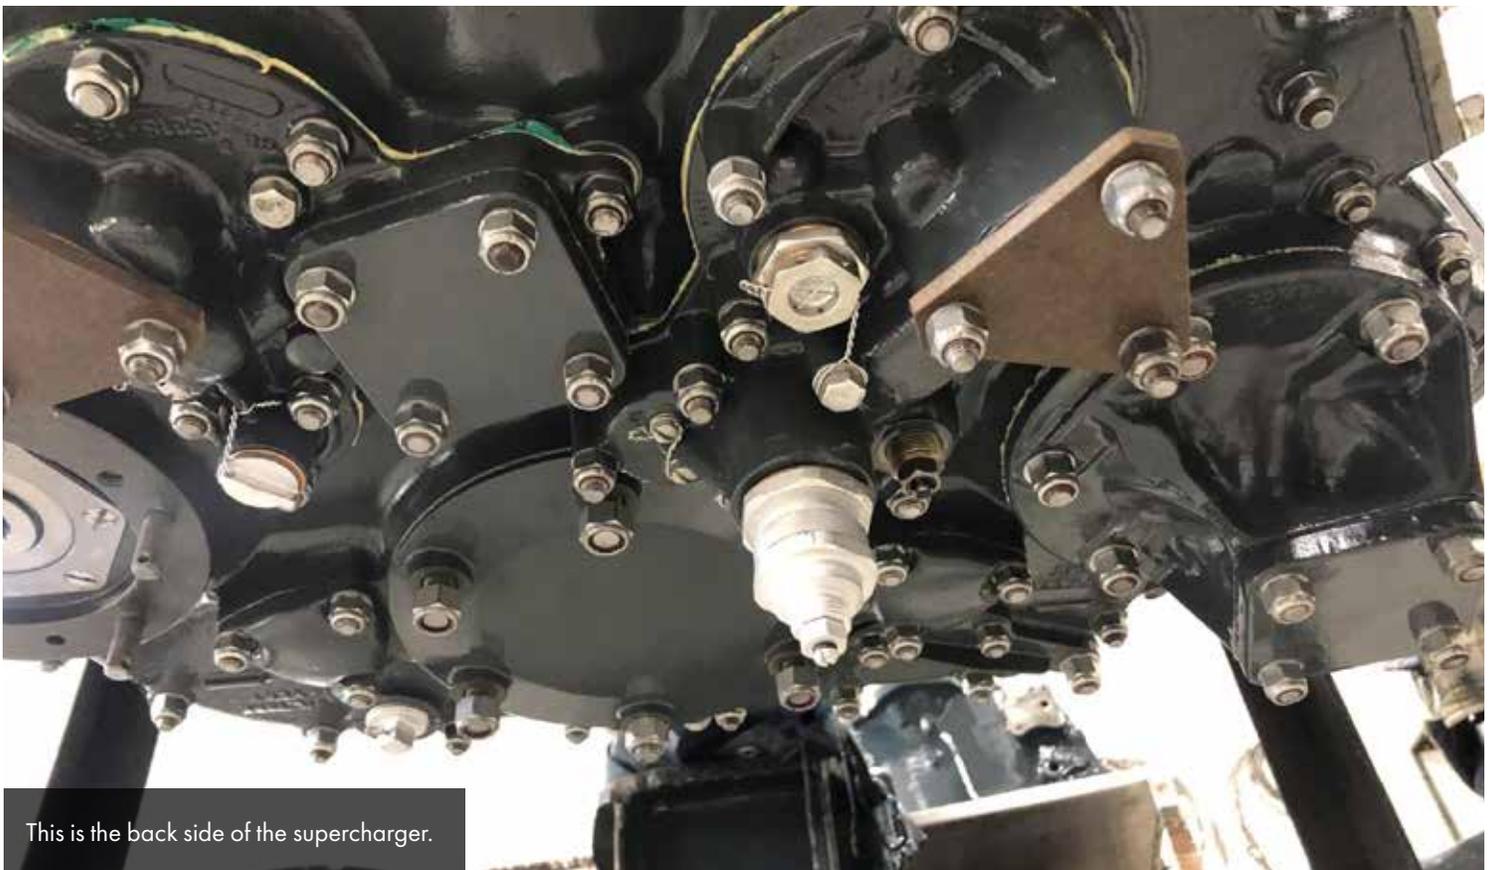
This is the back side of the supercharger.
