Dakota Territory Air Museum's P-47 Update

by Chuck Cravens and John Castorina

AIRCORPS AVIATION

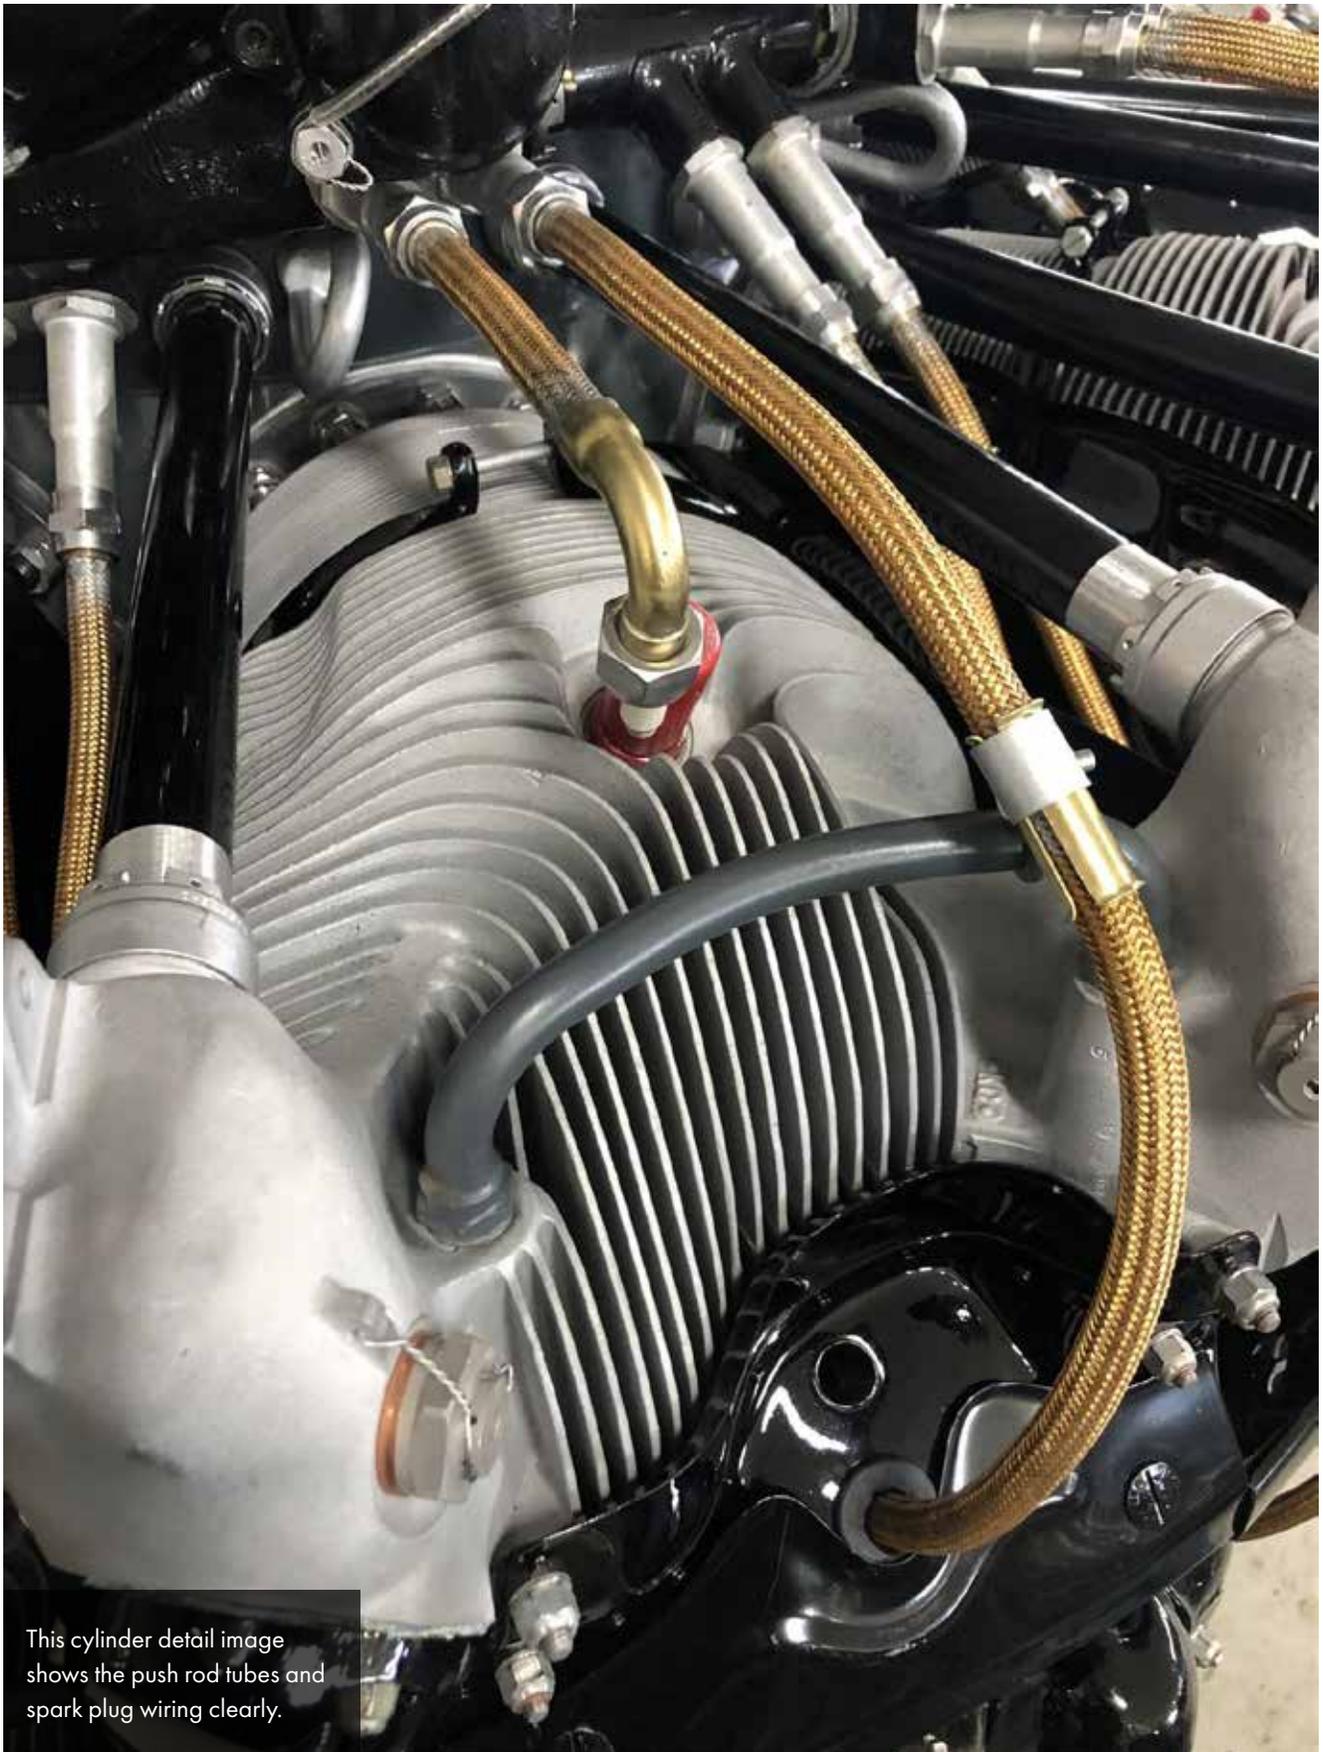
This cylinder detail image shows the push rod tubes and spark plug wiring clearly.
