Dakota Territory Air Museum's P-47 Update

by Chuck Cravens

This month, work continued on fuselage systems, the ailerons were riveted, and work was begun on the exhaust system. Some of the ducting for the turbosupercharger was fitted in conjunction with the exhaust system.

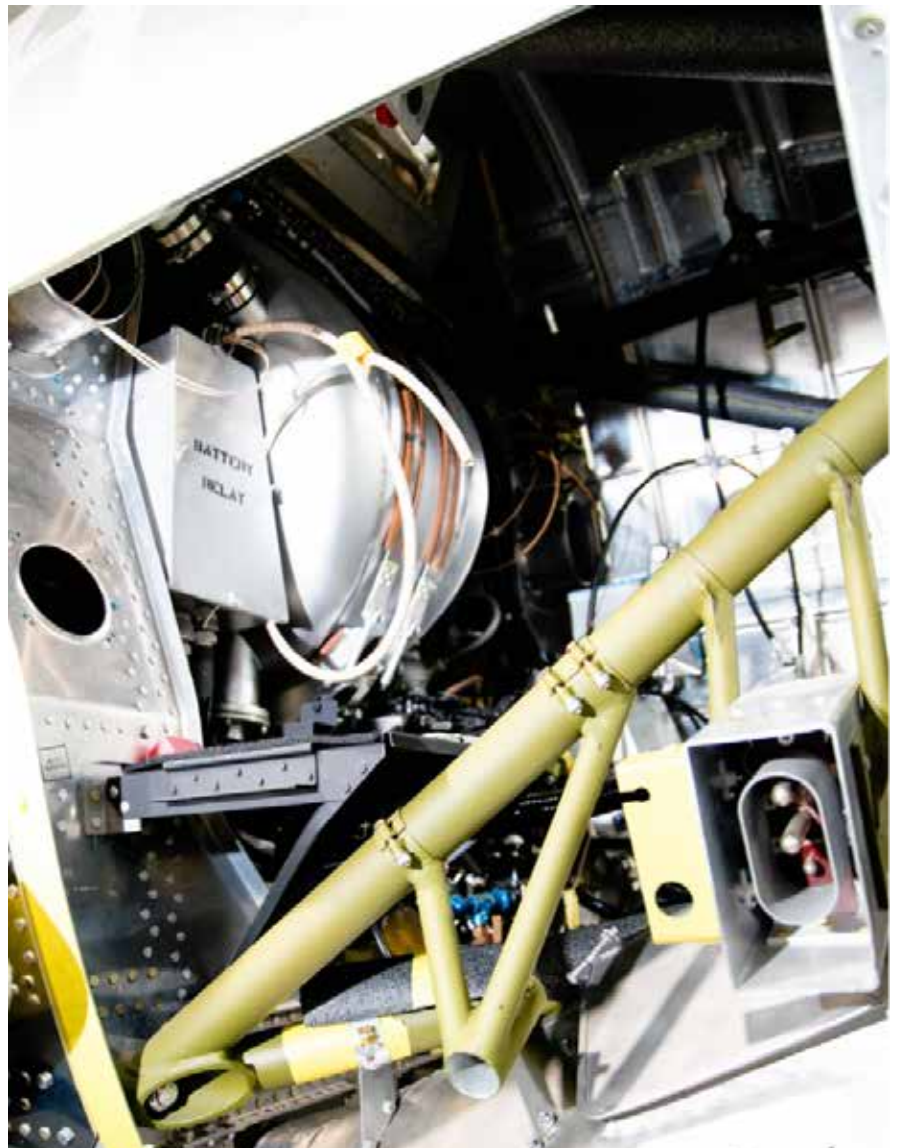
The black shelf, left center of the image, is where the battery will be mounted. The part of the motor mount with an open tube in the lower center is where the hand starter crank will go. Imagine hand cranking 2800 cubic inches of Pratt and Whitney radial!

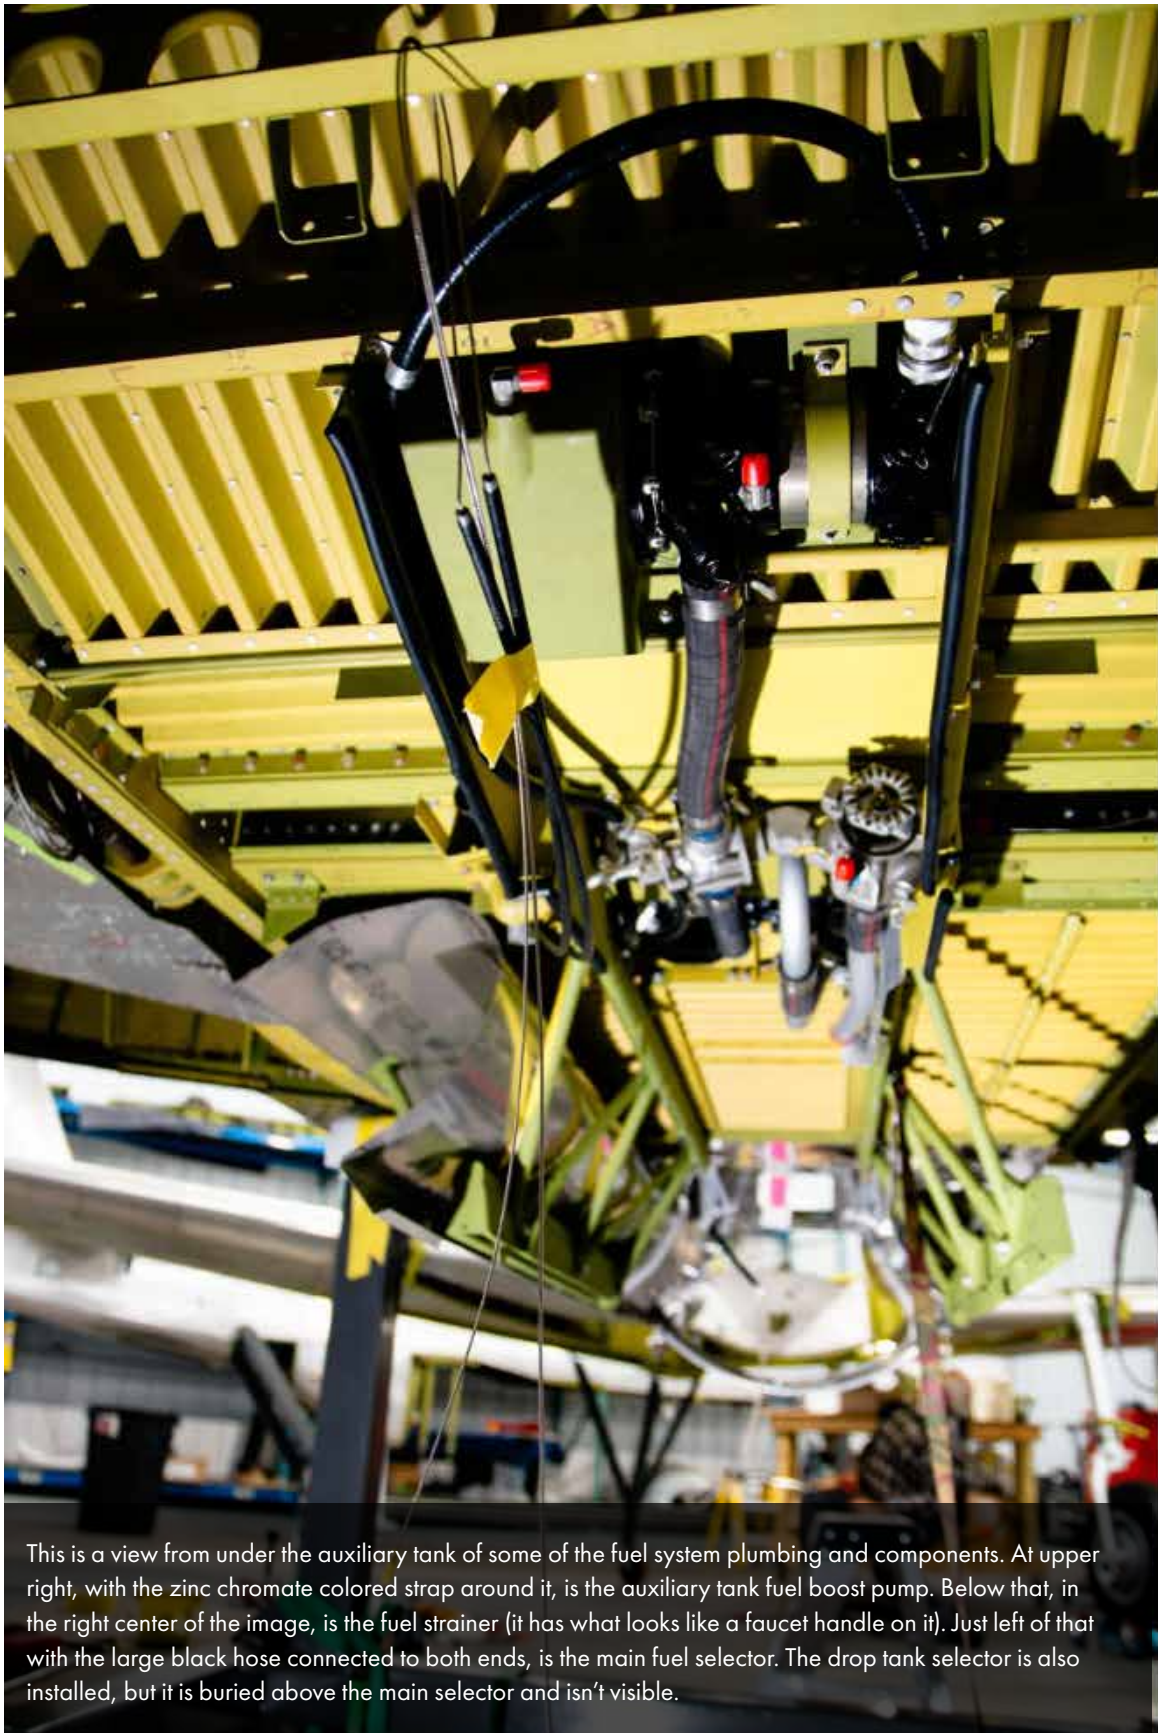
This is a view from under the auxiliary tank of some of the fuel system plumbing and components. At upper right, with the zinc chromate colored strap around it, is the auxiliary tank fuel boost pump. Below that, in the right center of the image, is the fuel strainer (it has what looks like a faucet handle on it). Just left of that with the large black hose connected to both ends, is the main fuel selector. The drop tank selector is also installed, but it is buried above the main selector and isn't visible.

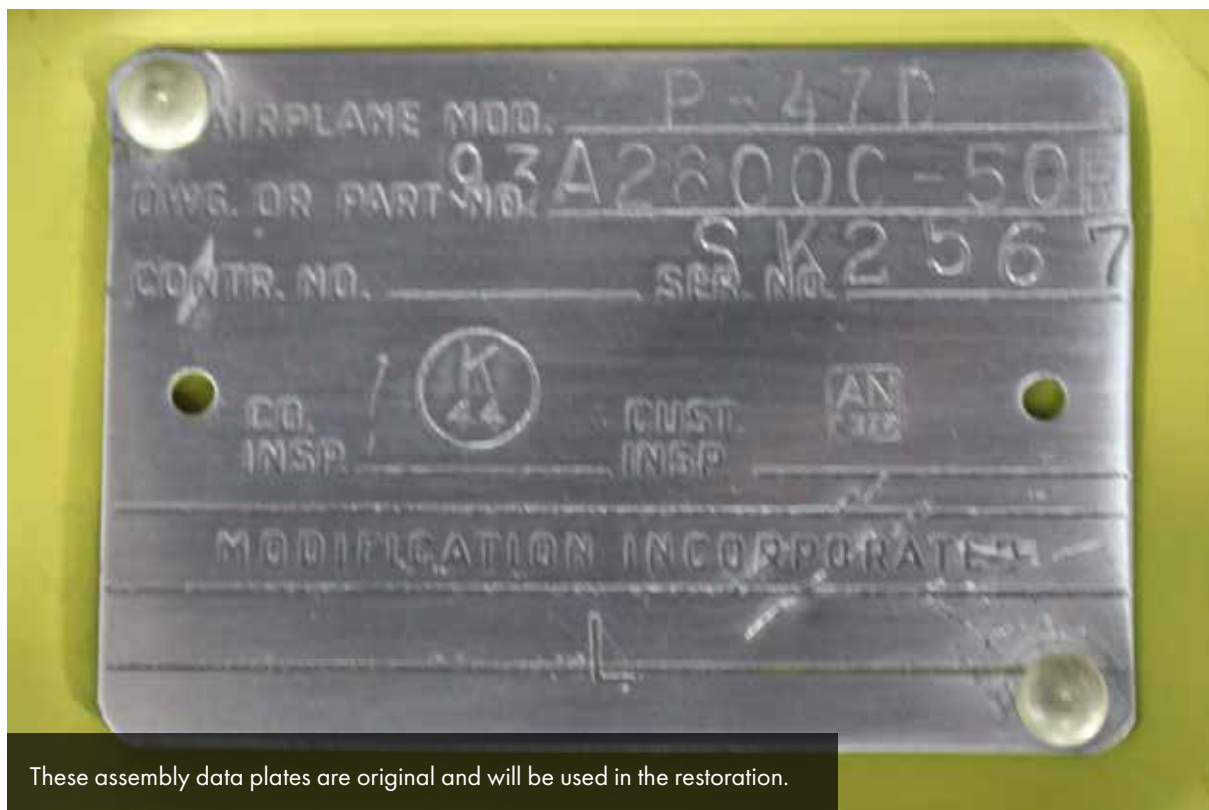
These assembly data plates are original and will be used in the restoration.

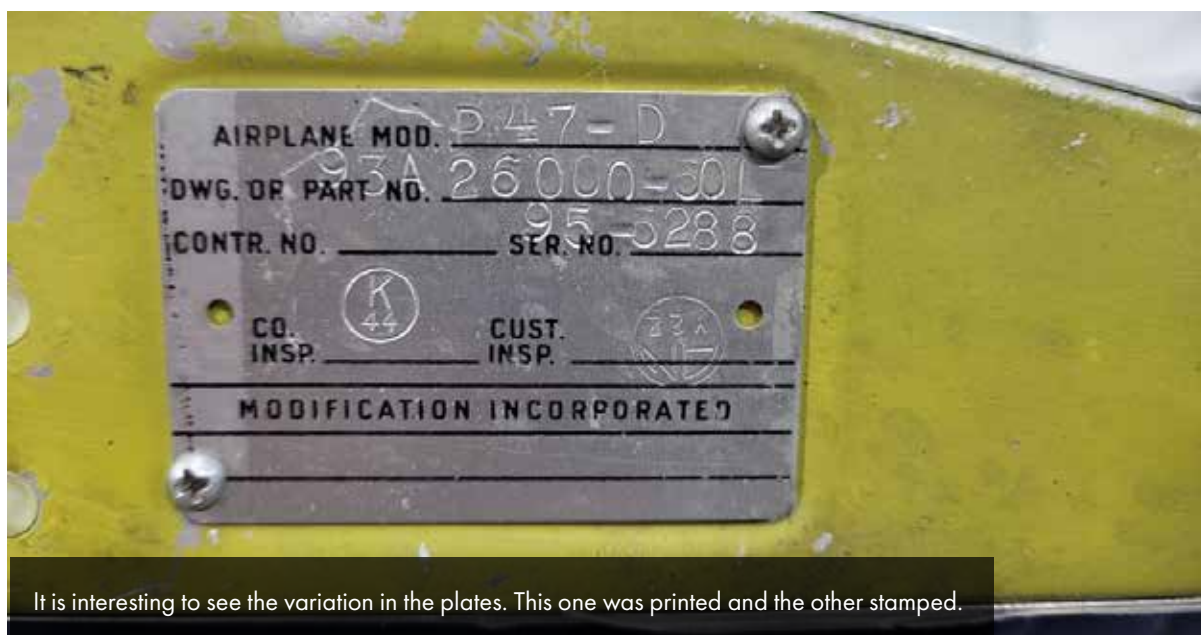
It is interesting to see the variation in the plates. This one was printed and the other stamped.

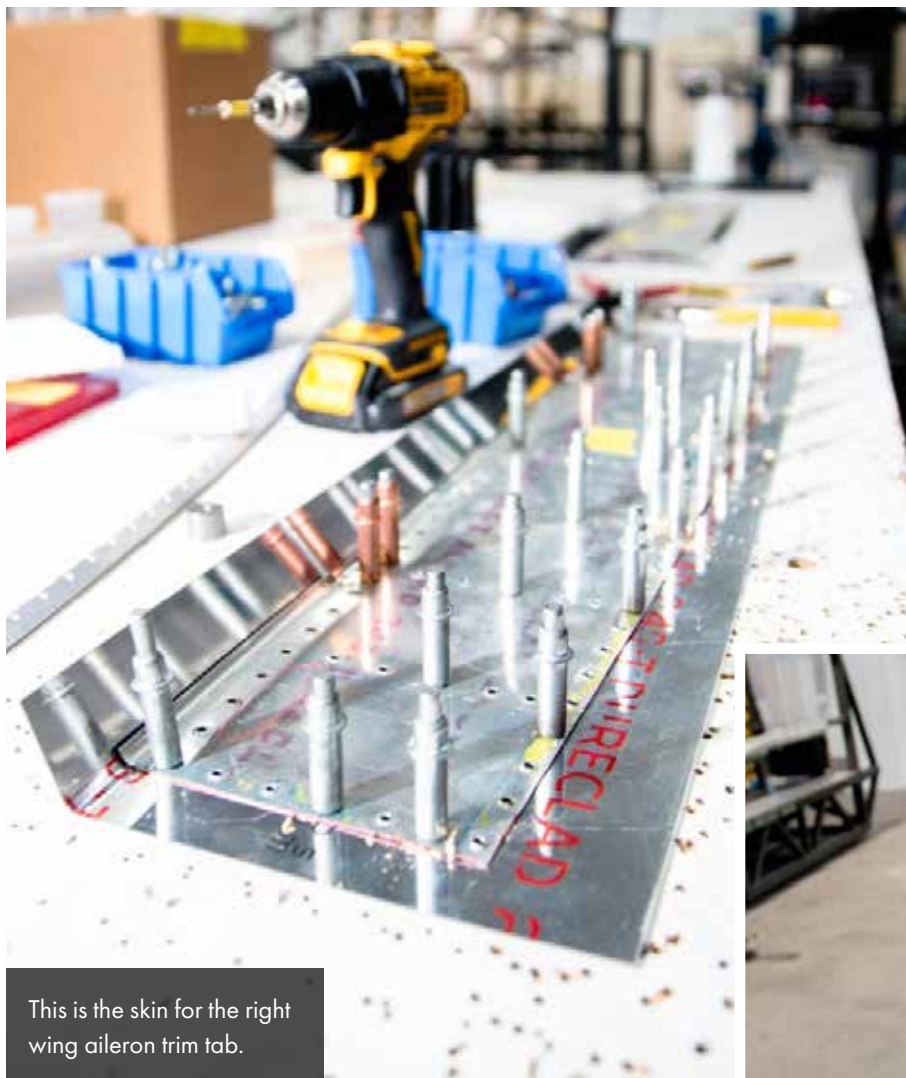
This is the skin for the right wing aileron trim tab.

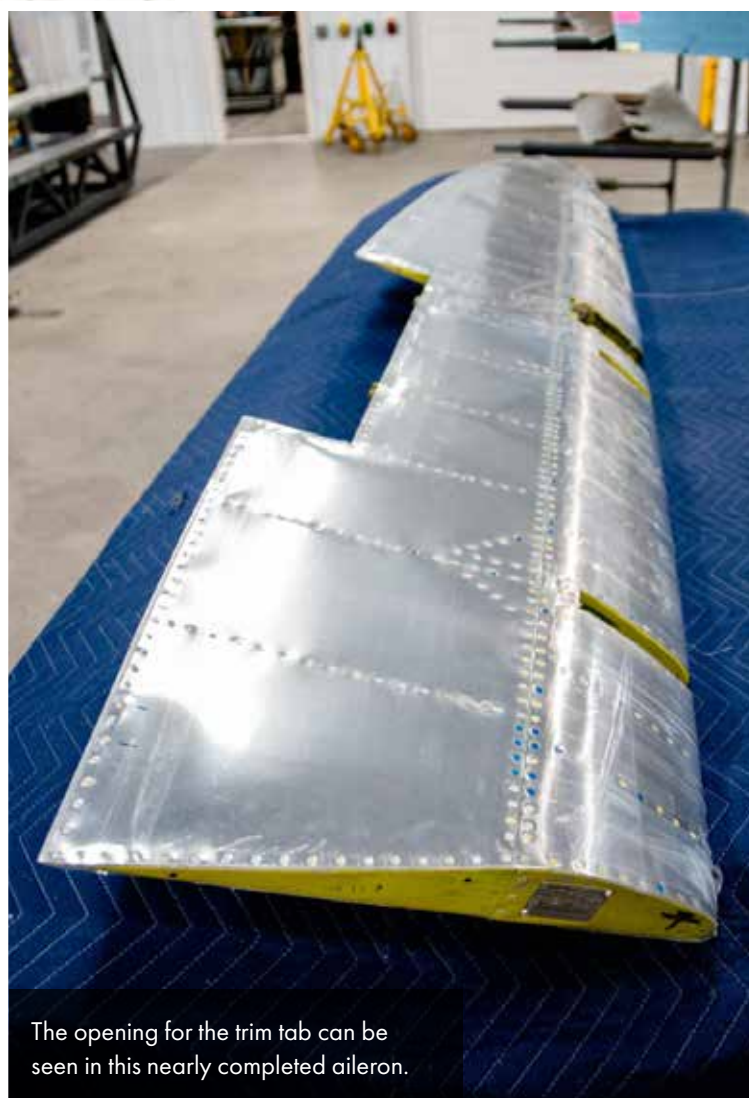
The opening for the trim tab can be seen in this nearly completed aileron.

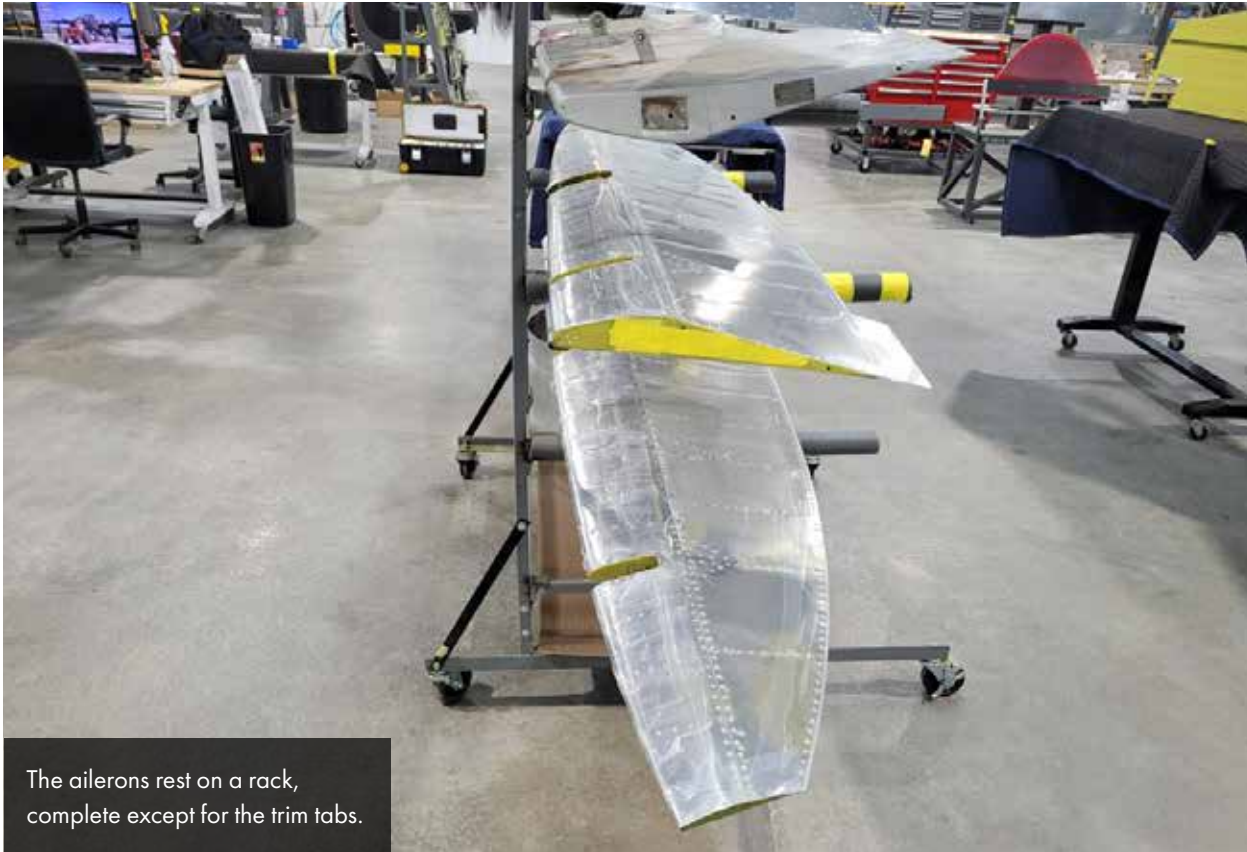
The ailerons rest on a rack, complete except for the trim tabs.

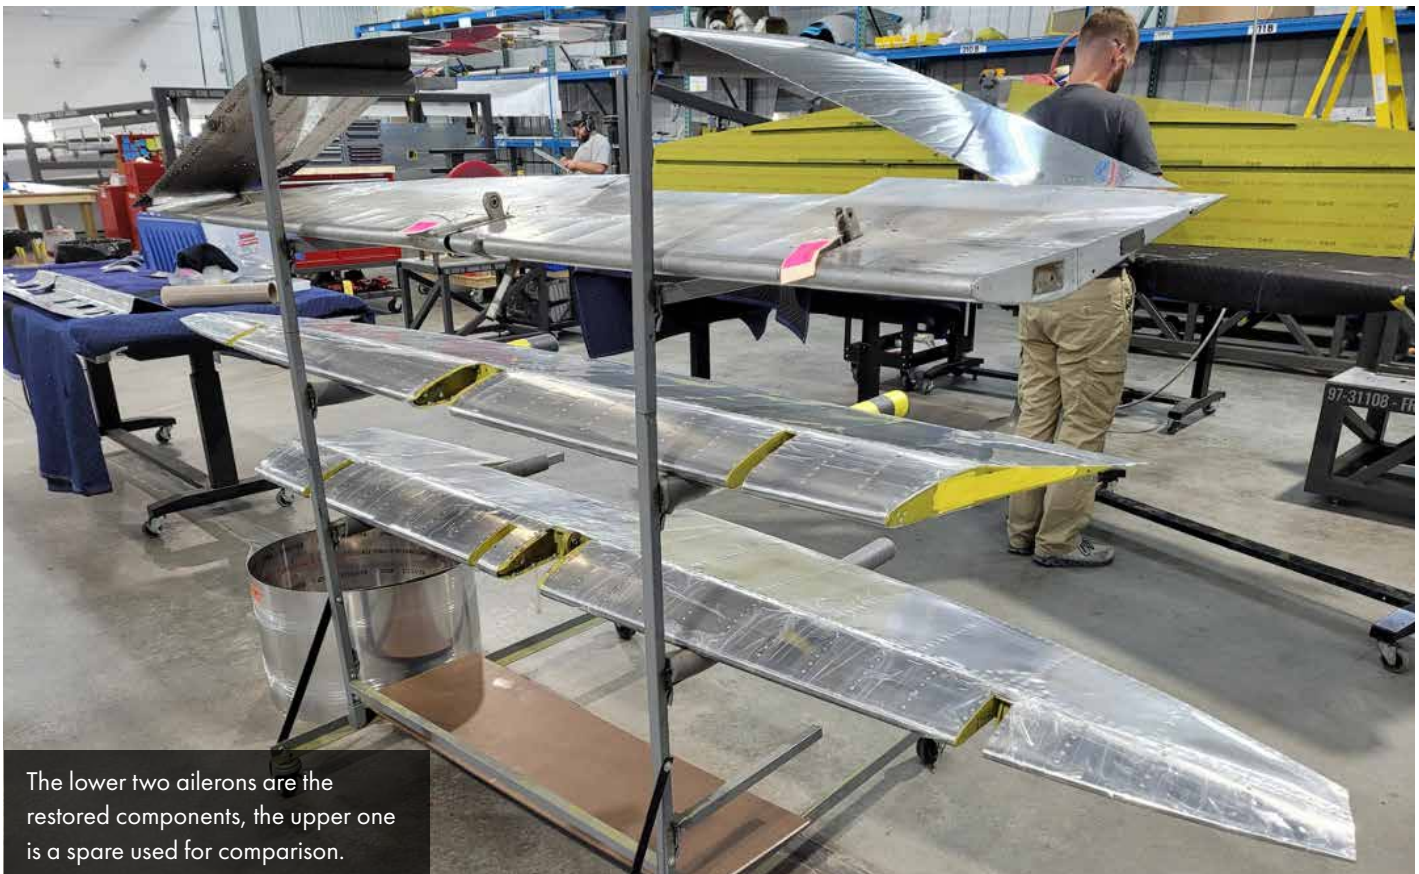
The lower two ailerons are the restored components, the upper one is a spare used for comparison.

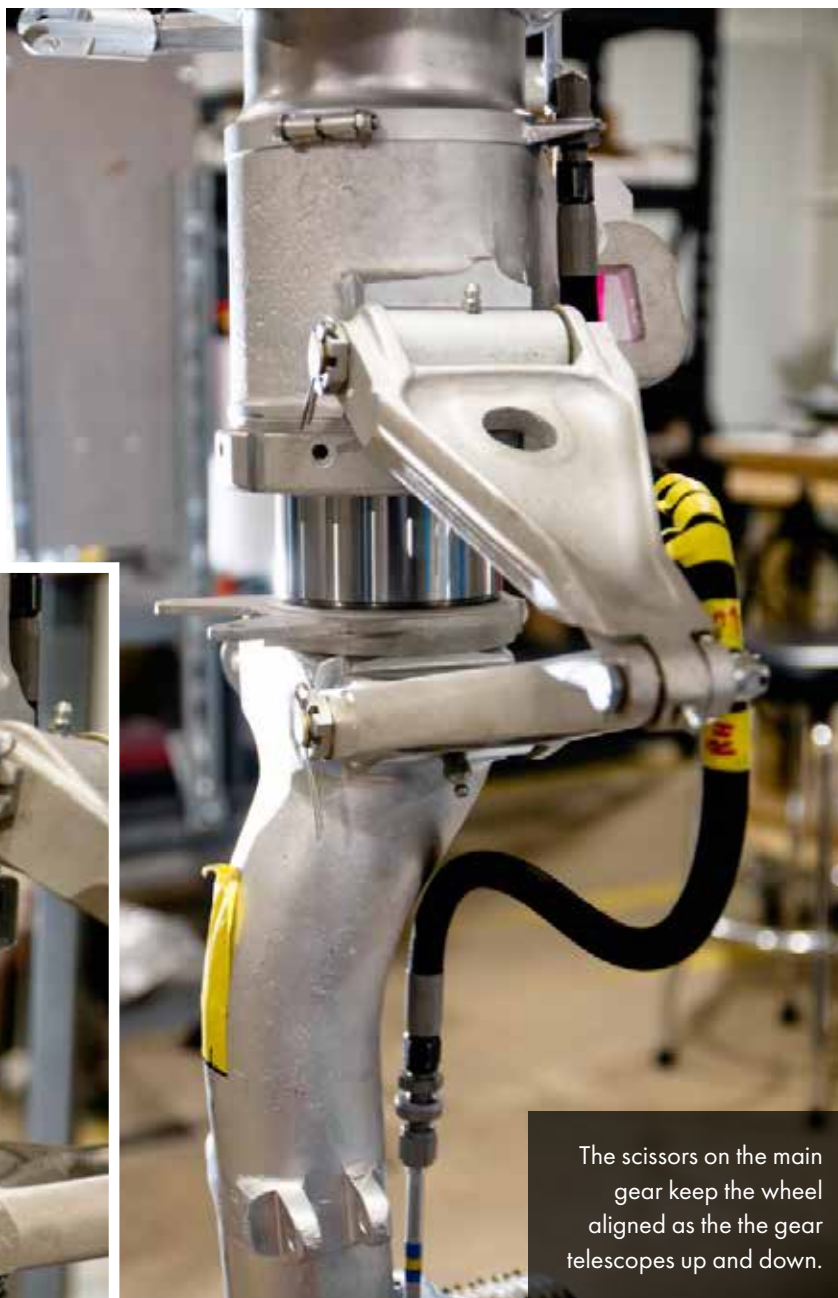
The scissors on the main gear keep the wheel aligned as the gear telescopes up and down.

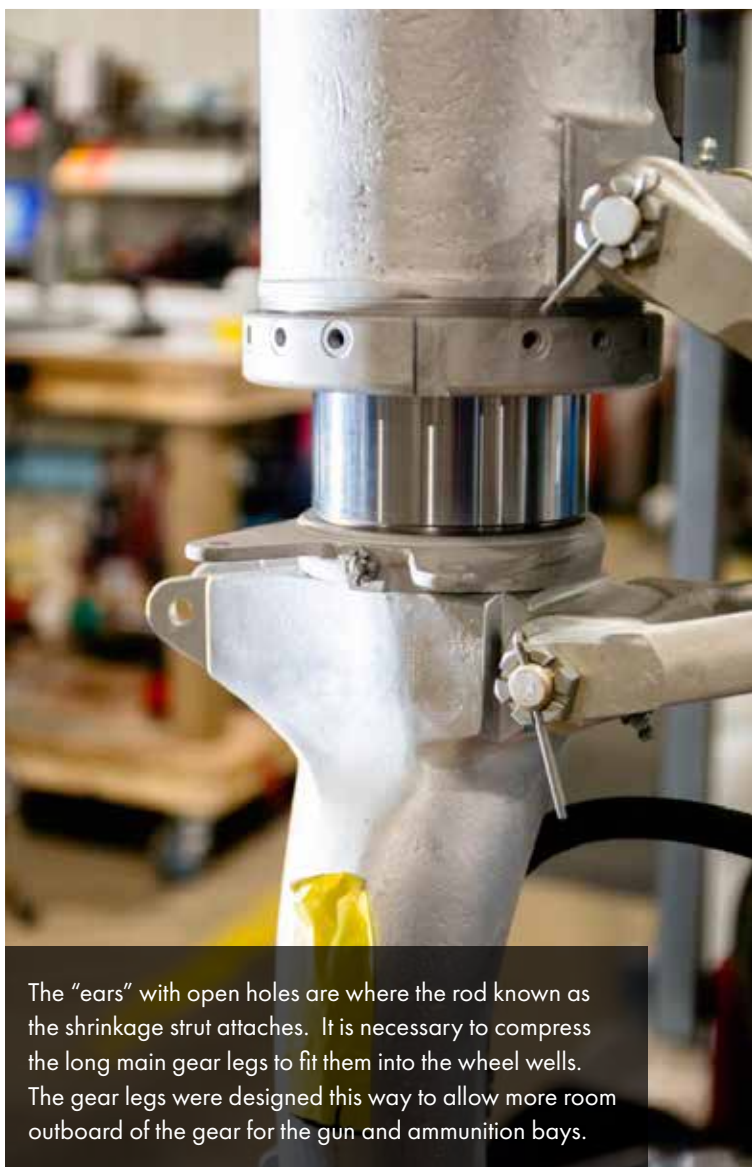
The "ears" with open holes are where the rod known as the shrinkage strut attaches. It is necessary to compress the long main gear legs to fit them into the wheel wells. The gear legs were designed this way to allow more room outboard of the gear for the gun and ammunition bays.

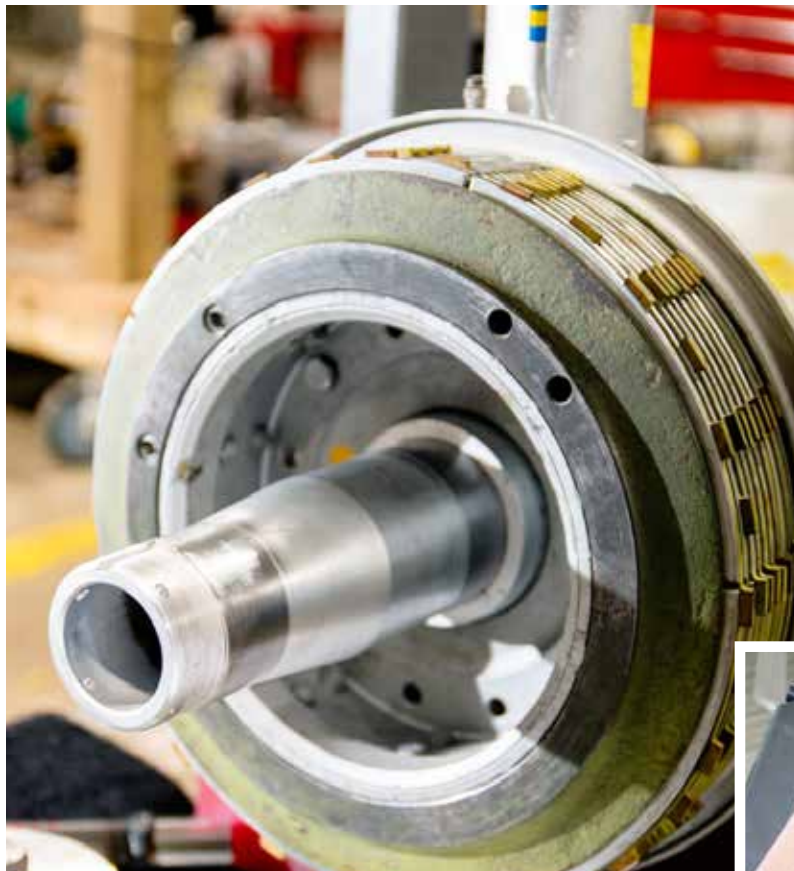
The multi disc brake assembly is in place on the axle. For this restoration, General Electric P-47N brakes are being used because their multi disc design is safer. The original brakes in a P-47D-23 would have been drum brakes that can fade because they don't dissipate heat as readily as the disc design.

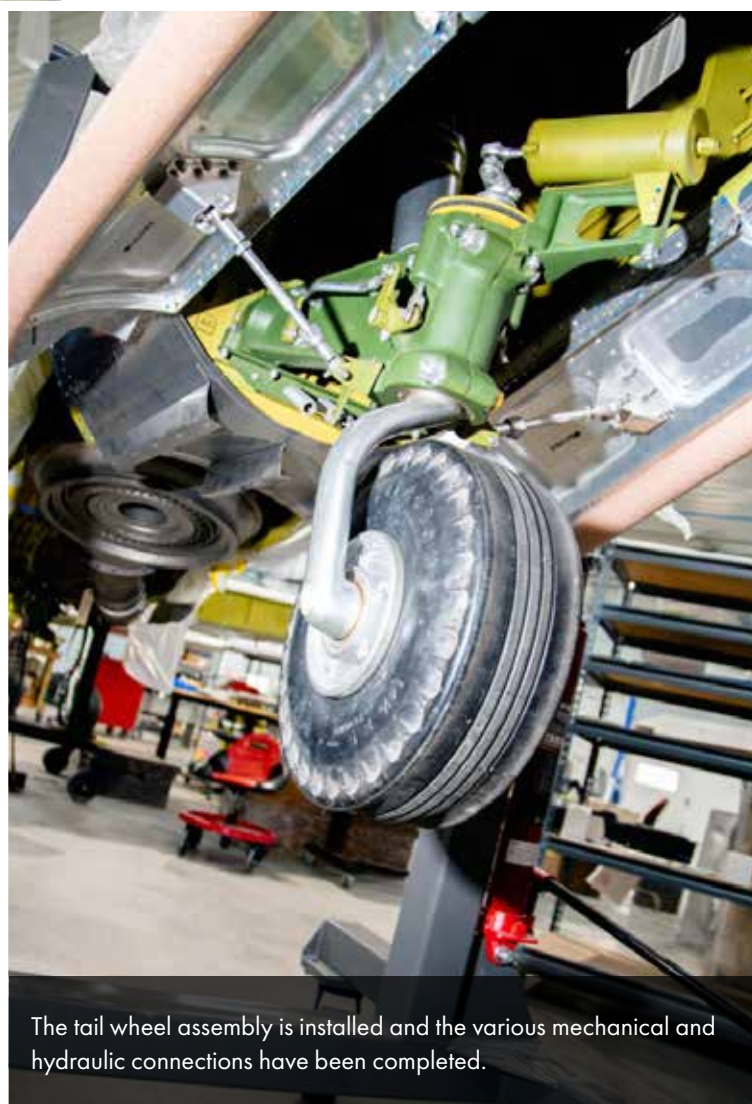
The tail wheel assembly is installed and the various mechanical and hydraulic connections have been completed.

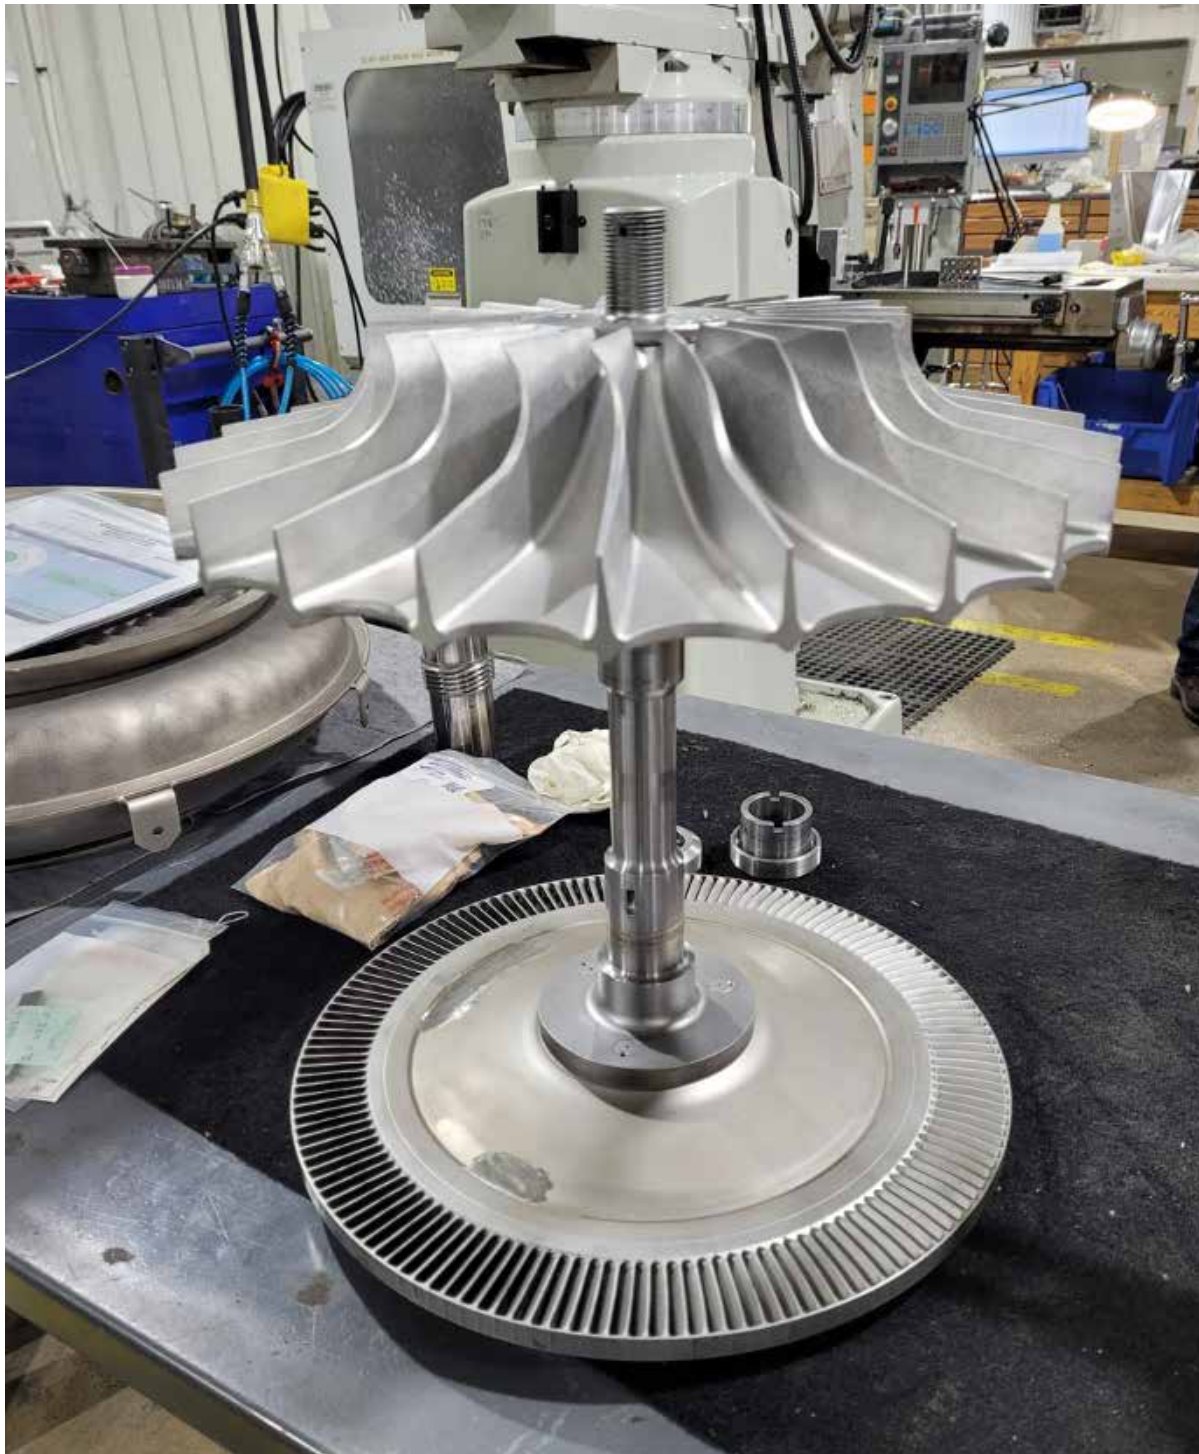
The impeller attaches to the top of the main turbosupercharger shaft and the bucket wheel is at the bottom. The bucket wheel is in the lower, hot section that drives the turbosupercharger by exhaust gas pressure, the impeller is in the upper, cooler section of the turbosupercharger, and compresses the air to feed the carburetor.

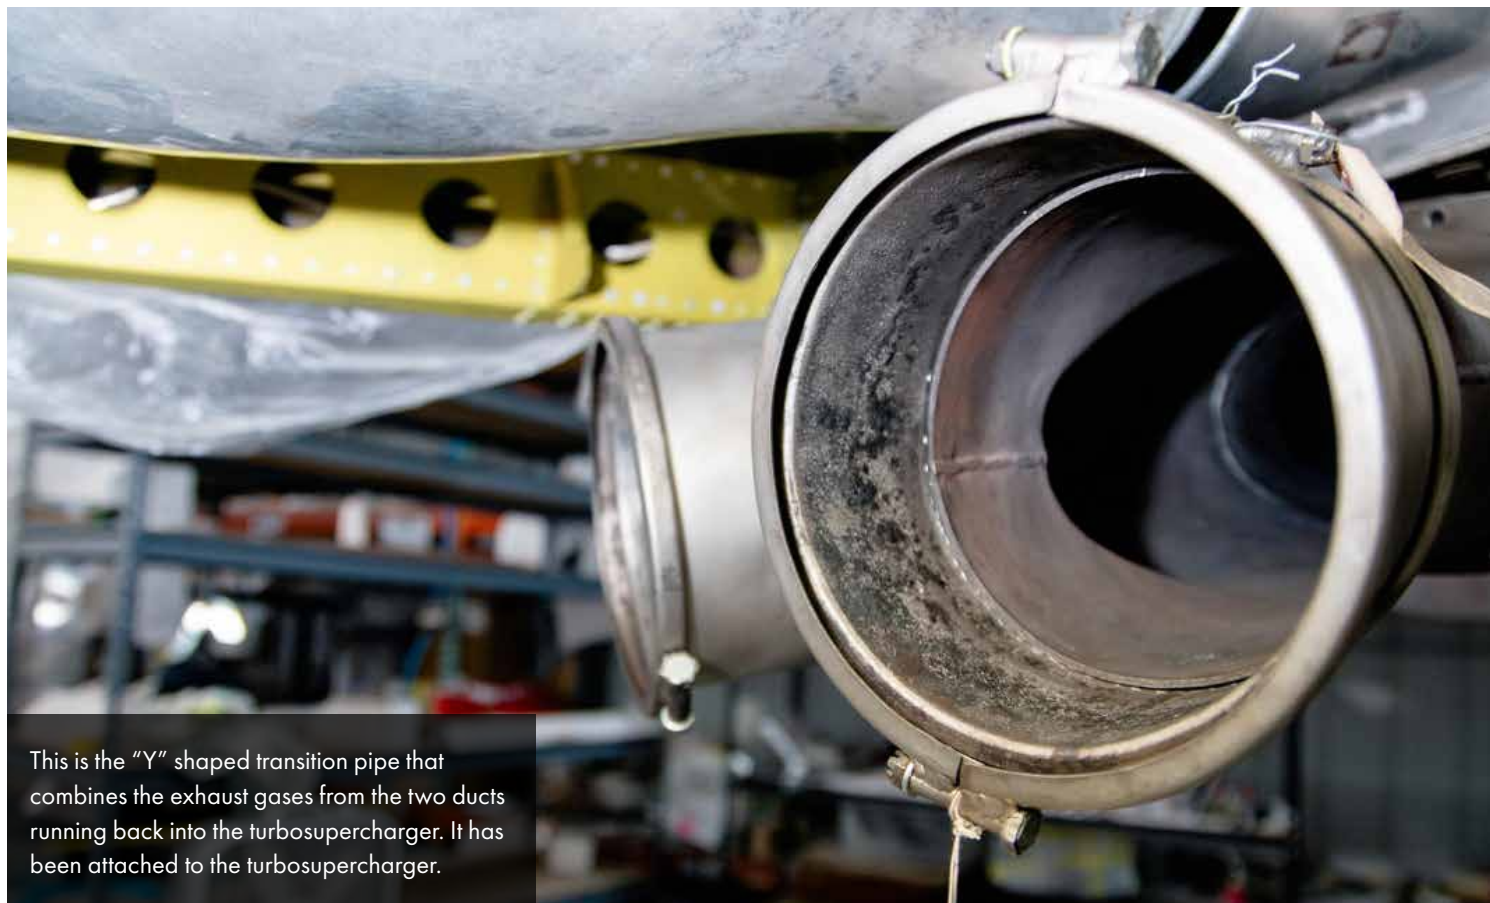
This is the "Y" shaped transition pipe that combines the exhaust gases from the two ducts running back into the turbosupercharger. It has been attached to the turbosupercharger.

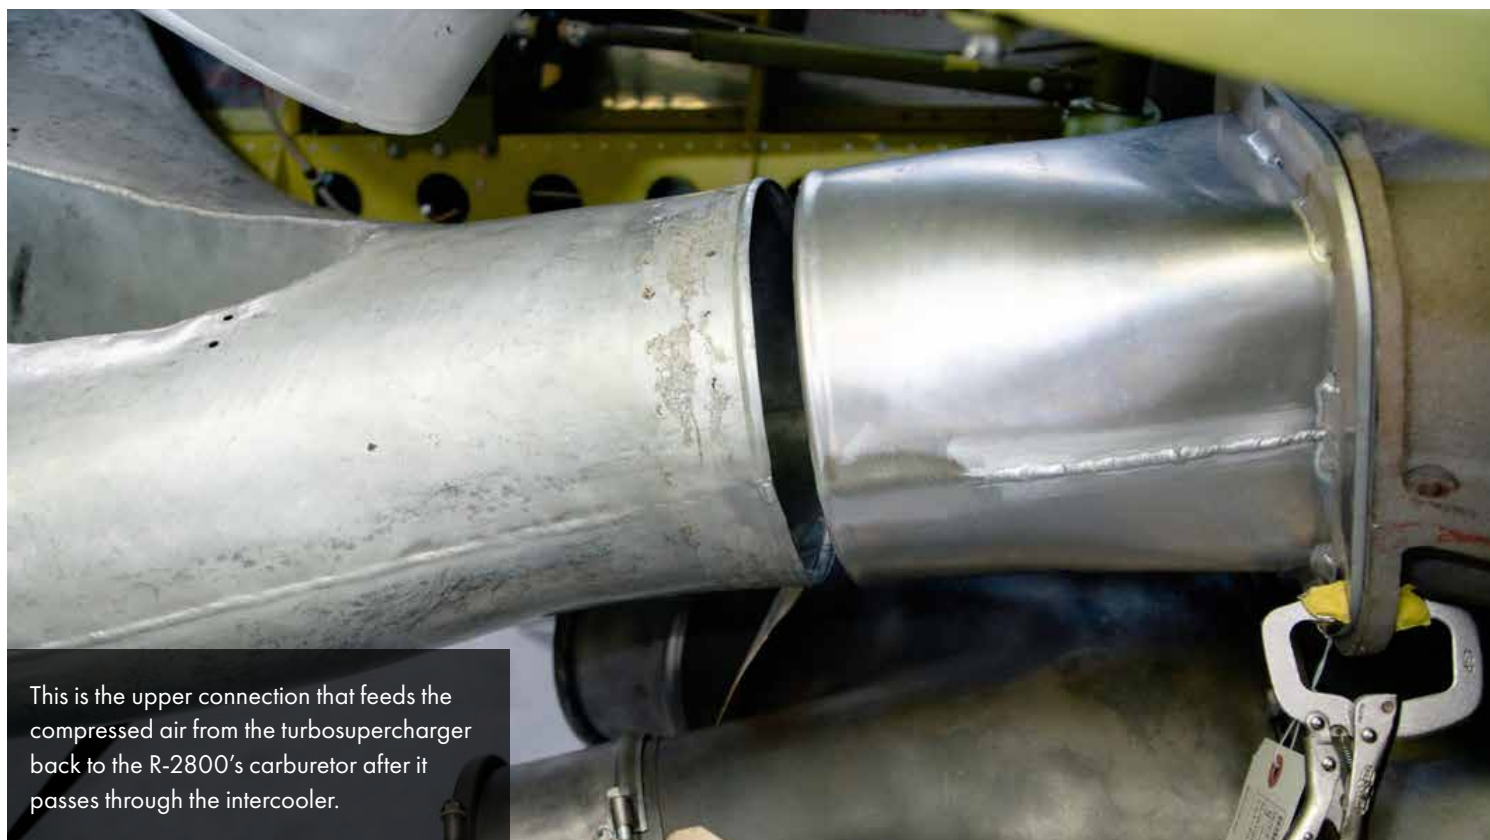
This is the upper connection that feeds the compressed air from the turbosupercharger back to the R-2800's carburetor after it passes through the intercooler.

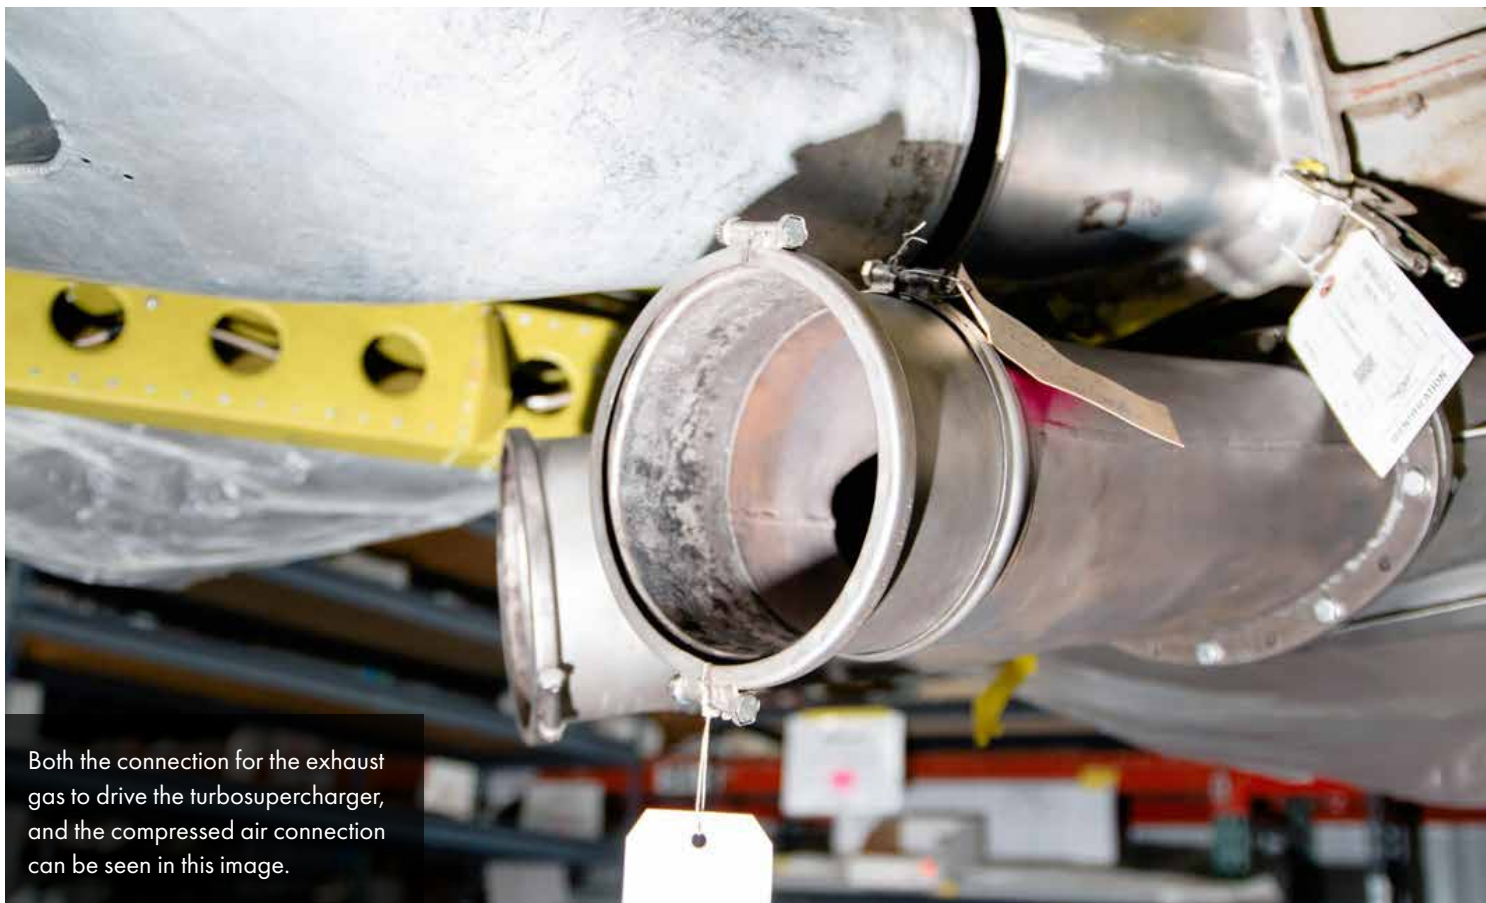
Both the connection for the exhaust gas to drive the turbosupercharger, and the compressed air connection can be seen in this image.

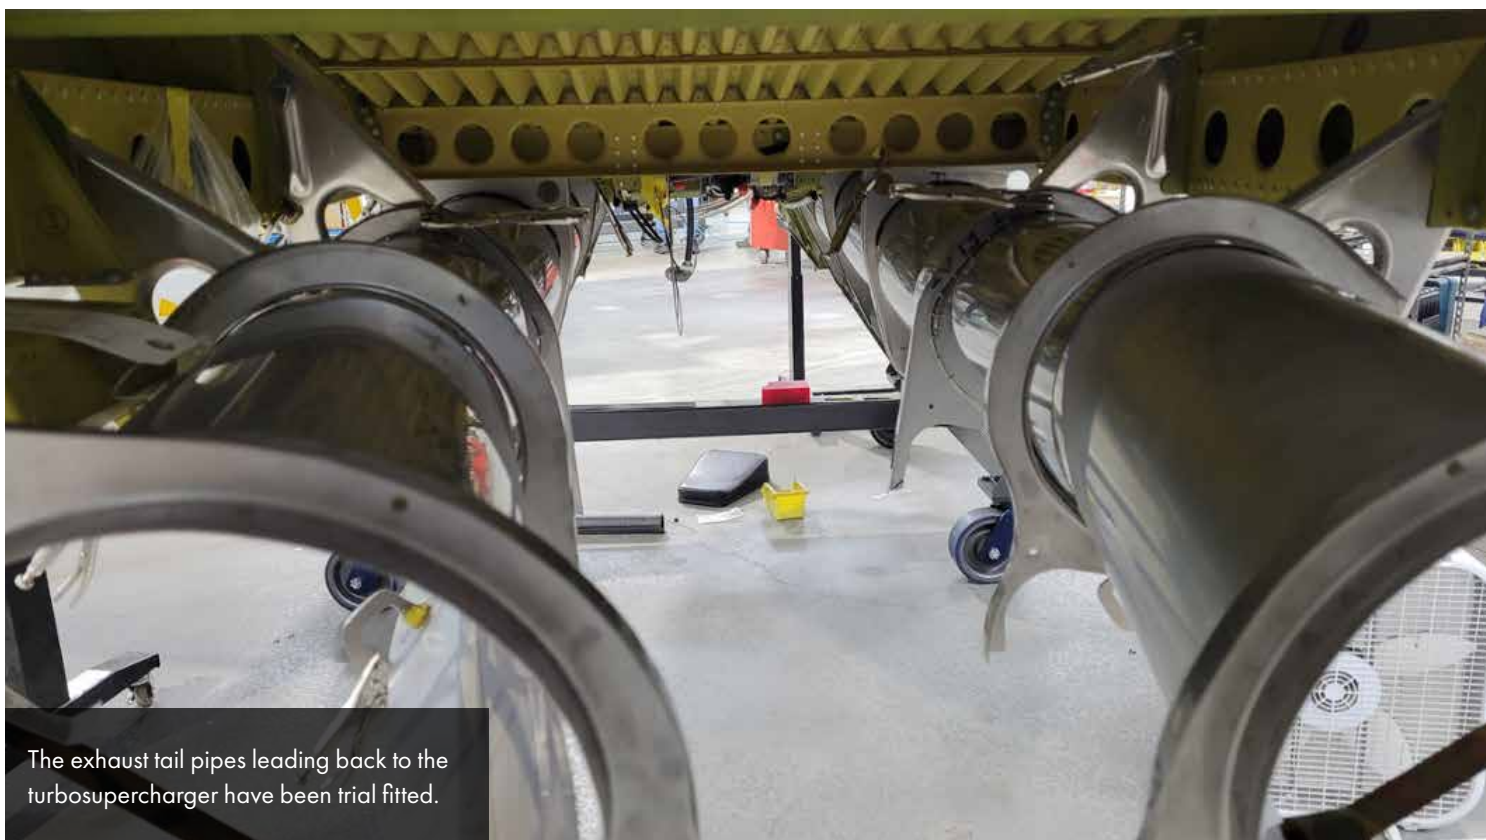
The exhaust tail pipes leading back to the turbosupercharger have been trial fitted.

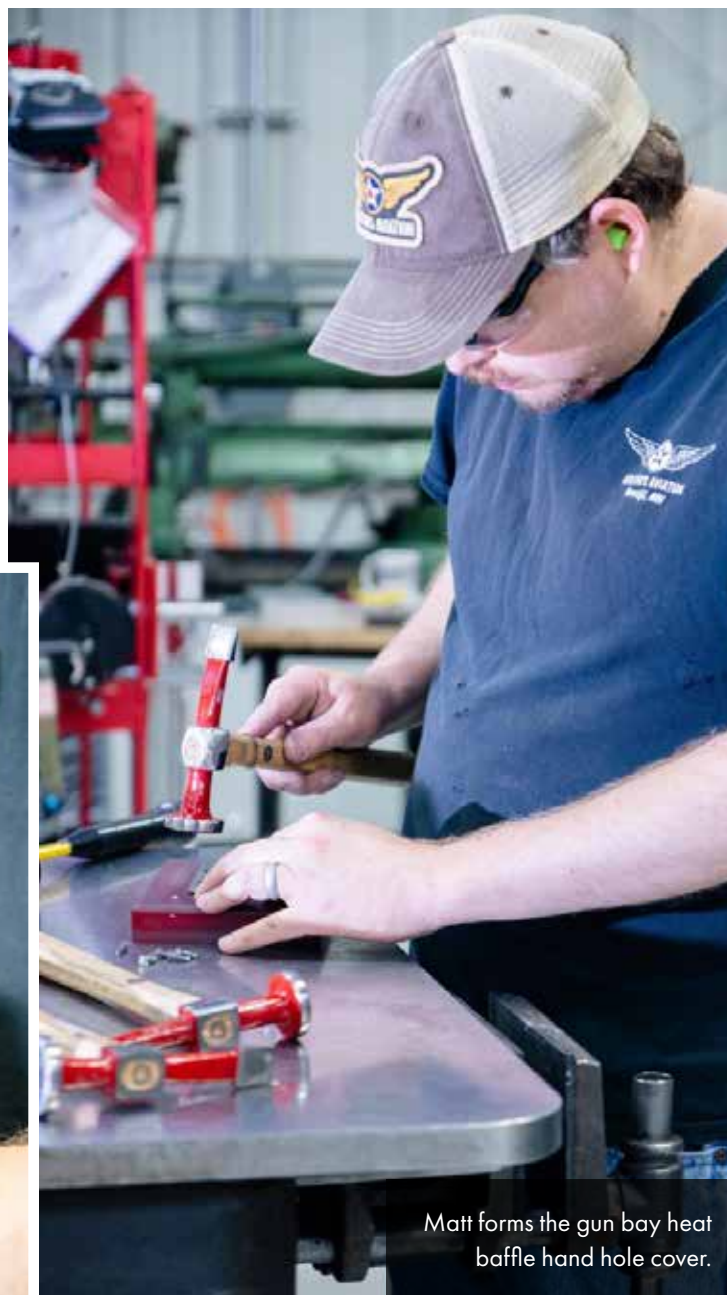
Matt forms the gun bay heat baffle hand hole cover.

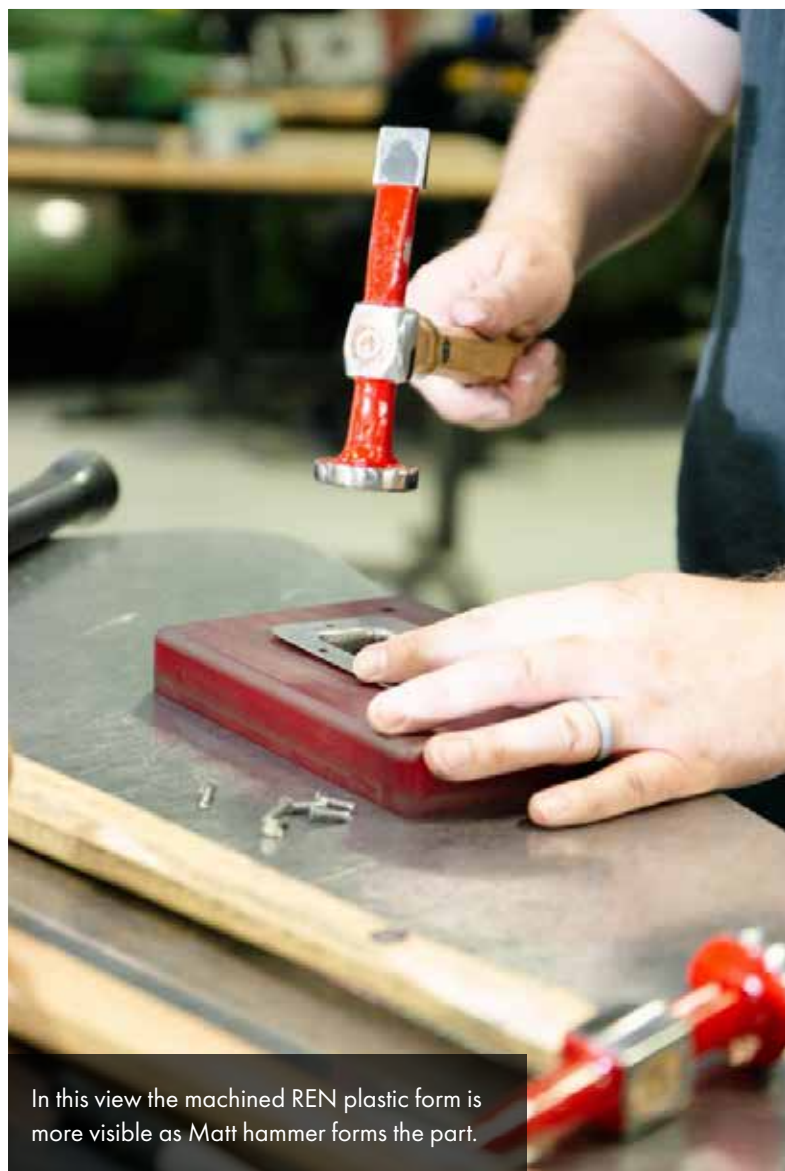
In this view the machined REN plastic form is more visible as Matt hammer forms the part.
