Dakota Territory Air Museum's P-47 Update

by Chuck Cravens

This month, work continued on fuselage systems, the ailerons were riveted, and work was begun on the exhaust system. Some of the ducting for the turbosupercharger was fitted in conjunction with the exhaust system.

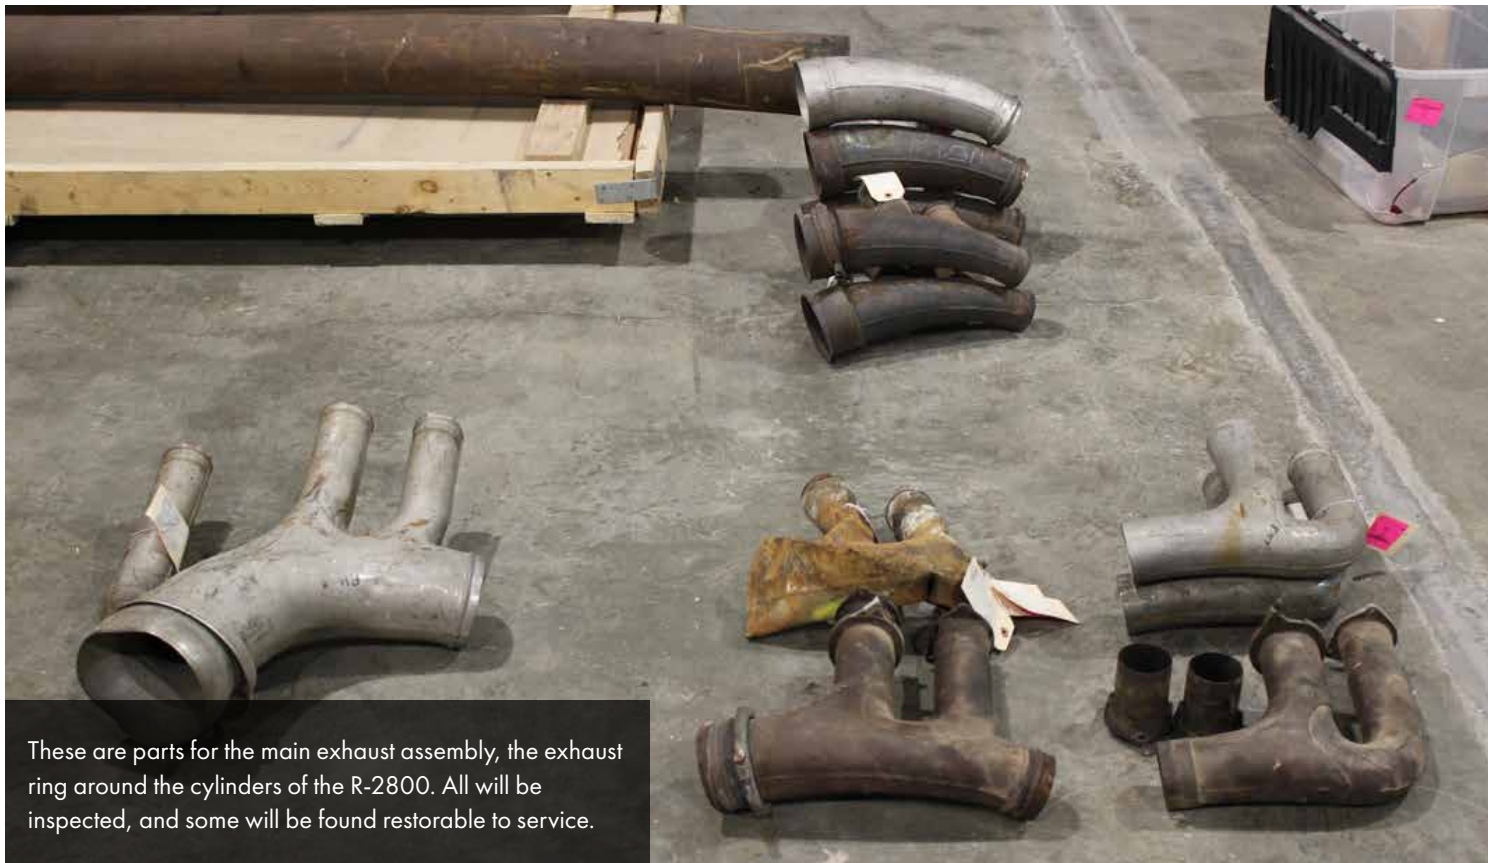
These are parts for the main exhaust assembly, the exhaust ring around the cylinders of the R-2800. All will be inspected, and some will be found restorable to service.

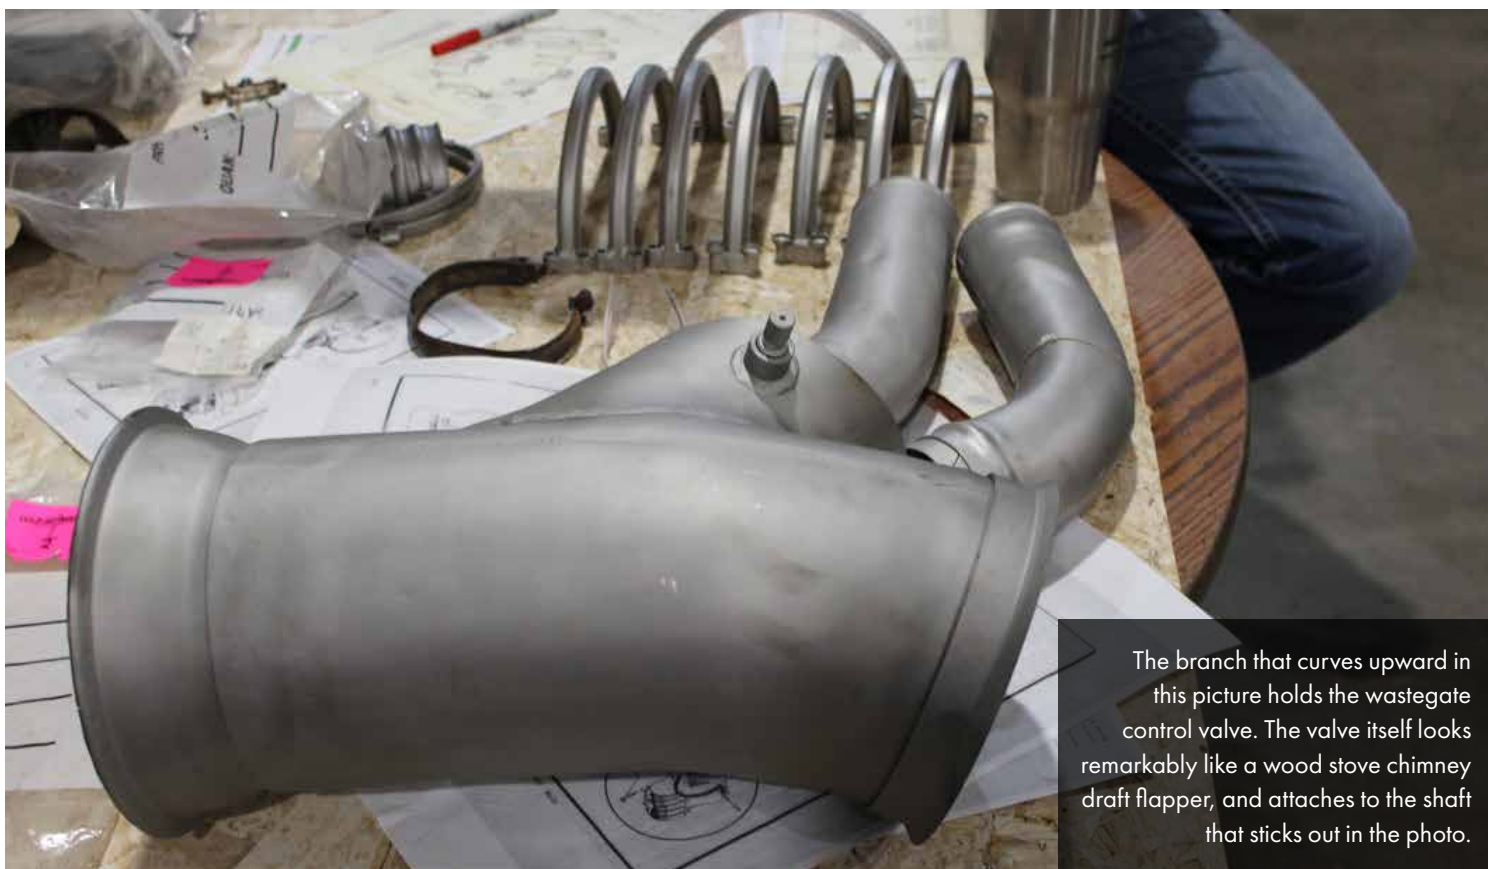
The branch that curves upward in this picture holds the wastegate control valve. The valve itself looks remarkably like a wood stove chimney draft flapper, and attaches to the shaft that sticks out in the photo.

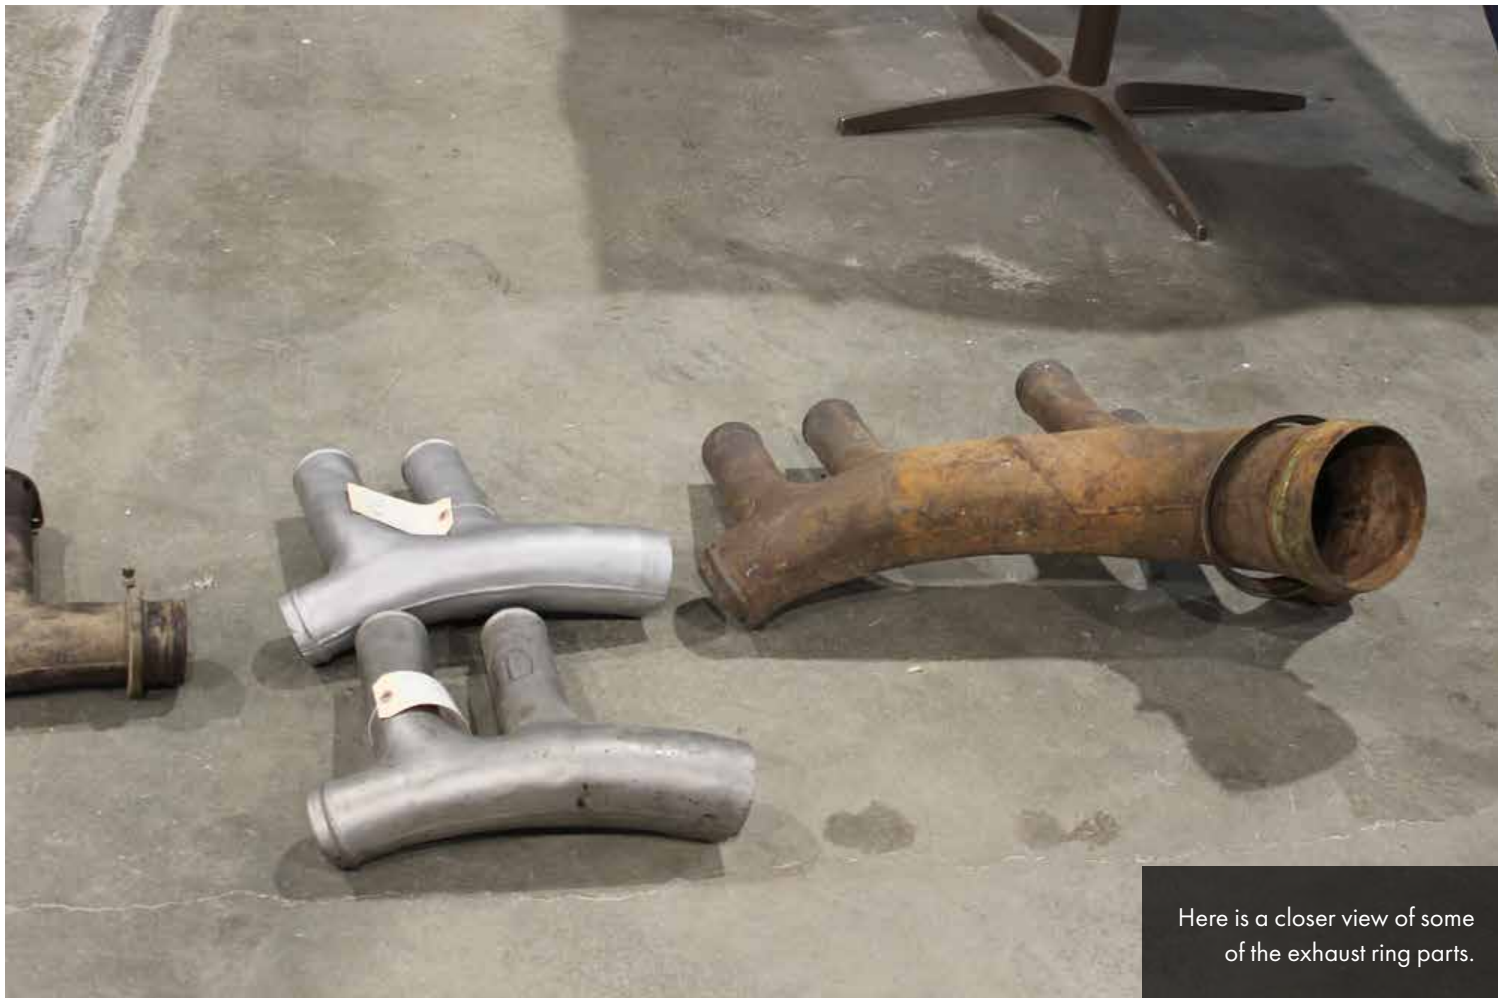
Here is a closer view of some of the exhaust ring parts.
